15th Canadian Masonry Symposium Ottawa, Canada June 2-5, 2025

Moving the Impenetrable

Masonry Conservation, Preservation Engineering, Adaptive Reuse, Building Move, Case Study

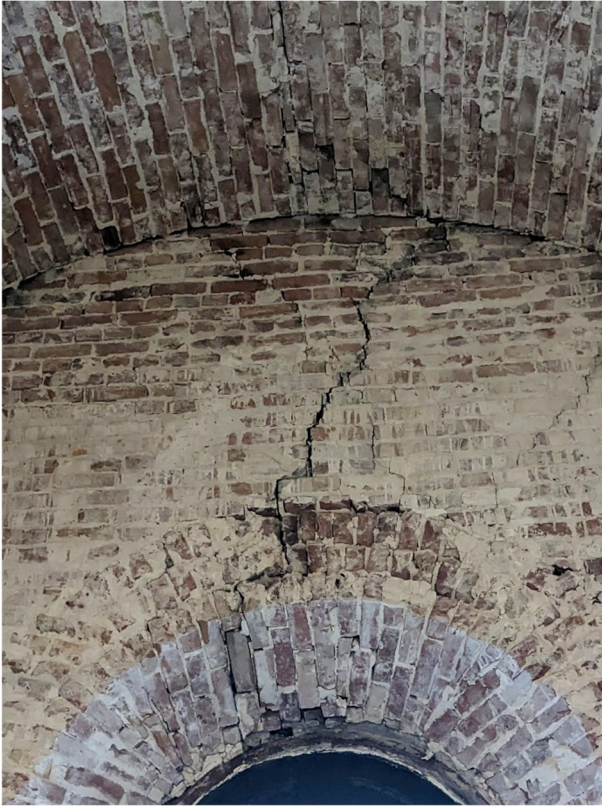
Upon removal of the plaster the original brick and soft lime mortar was exposed. There were some areas of cracking, especially at the south-west corner, where settlement had occurred, and above the windows in each of the three rooms. The interior brick walls were repaired with a Type O mortar and salvaged brick. Part of the end-state project includes a large opening in one of the interior walls, so replacement brick was harvested from this area. It was determined to not create the large opening before the move, to maintain the original integrity and redundancy. All cracks were repaired by carefully removing bricks adjacent to the crack and chasing the fracture through the depth of the six-wythe wall. Only cracked bricks were replaced, as the soft mortar allowed for simple salvage and reuse of the original bricks.

Figure 2a: Condition of the north wall, central room, before repairs [2022]

The intention of the interior repairs was to both repair existing cracks as well as strengthen the structure. The intersections of the perpendicular brick walls were repointed, ensuring any tying bricks were replaced and rebonded. The deterioration above the windows was addressed with a combination of dismantle and rebuild and repointing. The dismantle area extended up in each interior room to the connection of the brick vault to the perpendicular walls. This connection was originally completely separate, but as part of the project keys were installed at the very apex of the vault, as a method to further tie the north and south walls to the interior structure. The window arches were also fully repointed with minor resetting required.

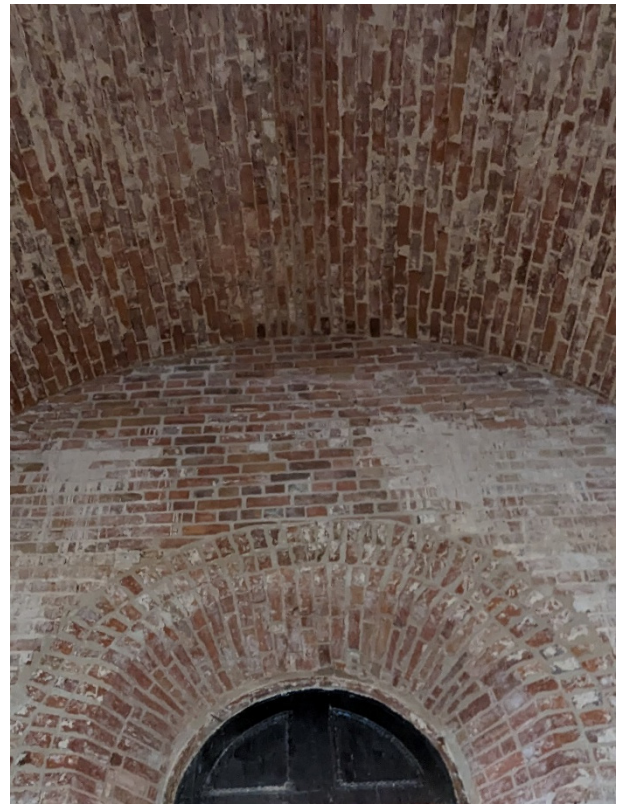
Figure 2b: Condition of the north wall, central room, after repairs [2022]

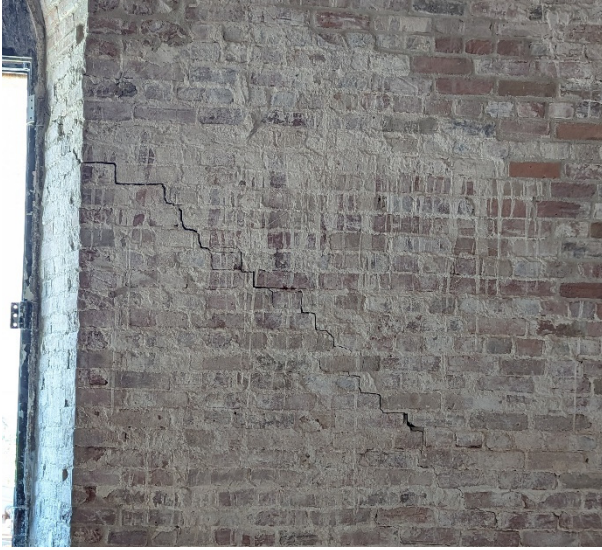
The first signs of the additional compaction that was occurring in the fill was cracking in the brick mortar joints. Cracking was occurring at the connection of the north and south masonry walls from the perpendicular walls, and cracking in the vault. The engineers on site quickly identified the cause of the cracking. At this time the first of the five girders had moved onto the fill, resulting in a slight difference in elevation of the two girders holding the north wall, tilting it down slightly to the north. The outward tilting of the north wall correlated with the evidence of the cracking in the connection to the perpendicular walls as well as the separation in the vault as it was being pulled.

The theory was put to the test as the second of the girders transitioned from the concrete to the fill. As expected, the separation of the side walls and vaults closed in slightly, and instead step cracking formed in the north-south walls, on the north side of the windows. The step cracking was reminiscent of typical settlement cracks.

As the third, central girder settled over the transition, the settlement crack shifted to the south. The cracks on the north side of the window mostly closed in and new cracking formed on the south side of the window. The fourth girder further closed in the cracking, and as the final girder transitioned over the change in subgrade material most of the cracks closed, see Figure 6.

Figure 6a: West wall condition during the move [2023]

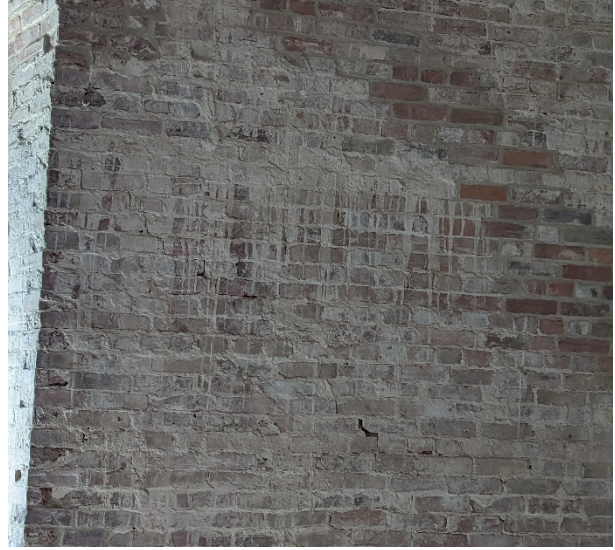
Figure 6b: West wall condition after the move [2023]

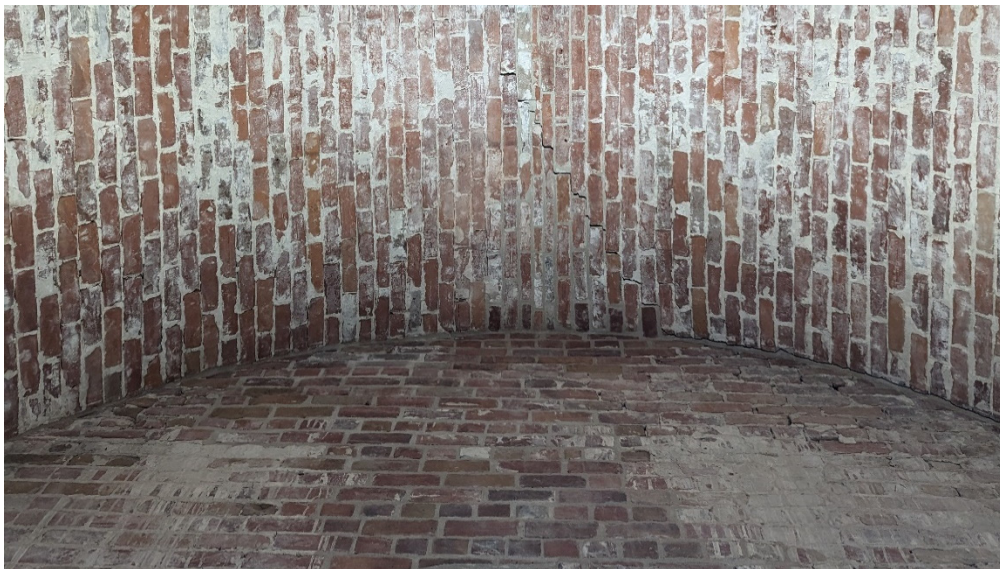
One of the main takeaways was where masonry was dismantled and rebuilt with proper keying this provided an extremely strong connection that remained intact during the move. As demonstrated in Figure 7, the cracking almost always occurred in the original soft mortar, not through the repair mortar. This was especially highlighted where the keys were added at the connection of the vault peaks to the perpendicular wall. The cracking that occurred bypassed the new keys and travelled instead through the original mortar around the repair. This indicates the inherent strength in simple masonry bonding.

Figure 7: Cracking/separation of brick vault from perpendicular walls [2023]
