Application and Evaluation of the New Standard for Existing Masonry Structures: Case Studies and Proposed Refinements

Heather Sustersicⁱ, Arezu Feizolahbeigiⁱⁱ, Patrick Dillonⁱⁱⁱ, and
Teagan Allen-Raffetto^{iv}

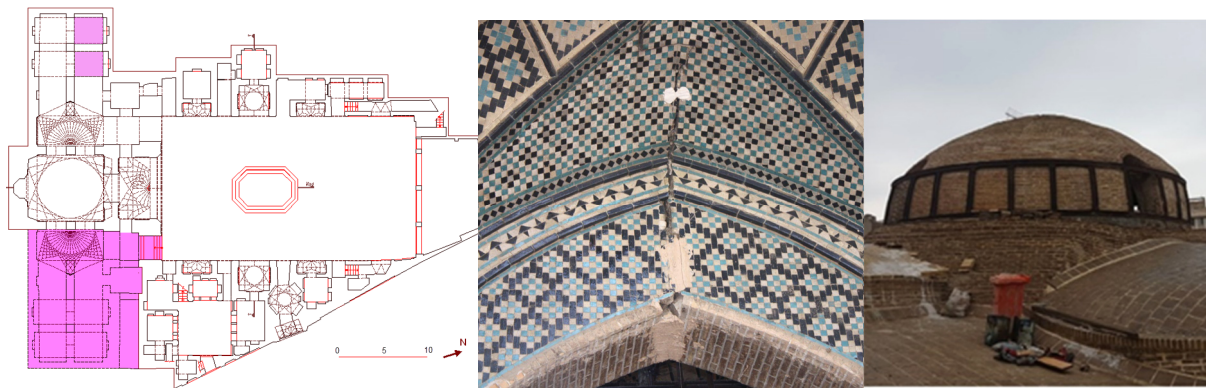
Severe structural distress is evident in the southern wall, with widespread settlement, deformation, and structural failure. The load-bearing elements in this section exhibit tilting, bending, and wide cracks. Crack indicators demonstrate movements, confirming the ongoing settlement (Figure 1b). Field studies identify the southern area, particularly near the altar, the most critical zone, with settlements caused by water-saturated soil layers. Surrounding buildings display similar cracks, highlighting regional soil weaknesses. Moreover, due to the collapse of half of the western prayer hall's vault, the static load transfer path has been altered and disrupted in this area.

Attempts to mitigate the damage include installing six columns under the dome in 1964, connecting foundations with ties in 1973, enlarging the foundations of the dome hall with reinforced concrete in 1979, and a buttress behind the altar in 2018. A steel ring was later added around the dome to stabilize it (Figure 1c). However, these measures have failed to address underlying problems like groundwater infiltration and soil erosion. The metal ring, made of incompatible materials, now exacerbates damage through thermal expansion and contraction [5].

Figure 1: (a) The original plan of the mosque, the highlighted region indicates the collapsed parts through the ages; (b) Active crack in the pointed arch of the dome hall; (c) Structural intervention by adding a steel belt around the dome

Settlement is identified as the root cause of the building distress. The code Section 7.4.7, *Foundation Stabilization or Strengthening*, offers methods for repair of the foundation while Section 8.2.3.1, *Design of shoring and bracing*, outlines contractor responsibilities for temporary bracing and shoring. However, it should be noted that Section 7.4.7 does not address settlement issues, such as significant or ongoing settlements, which may require more detailed procedures or additional external resources for thorough

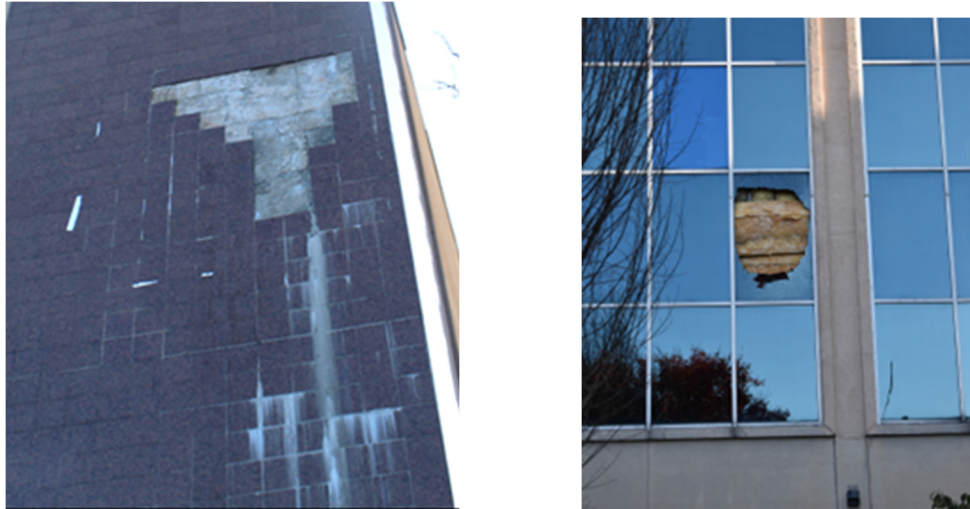
In 2021, a portion of the adhered granite tile veneer spalled off of the building (Figure 2a). The building owner also reported spontaneous window breakage (Figure 2b), interior water leakage, and cracking and other failures in the EIFS cladding. An investigation was performed to assess the causes of the deficiencies and develop a proposed repair scope for the building.

Based on the results of the investigation, it was determined that glass breakage was most likely caused by loose structural anchorages of the curtainwall framing system. Water leakage was observed to be caused by cracking and other deficiencies in the EIFS cladding, failure of sealant joint, deficiencies in the curtainwall and windows systems, and poor architectural detailing. The repair scope included fully replacing the EIFS cladding in-kind, replacing the curtainwall with ribbon windows, and installing an anchored brick veneer at the former location of the granite tiles.

Figure 2: (a) Spalled granite tiles; (b) Broken glass

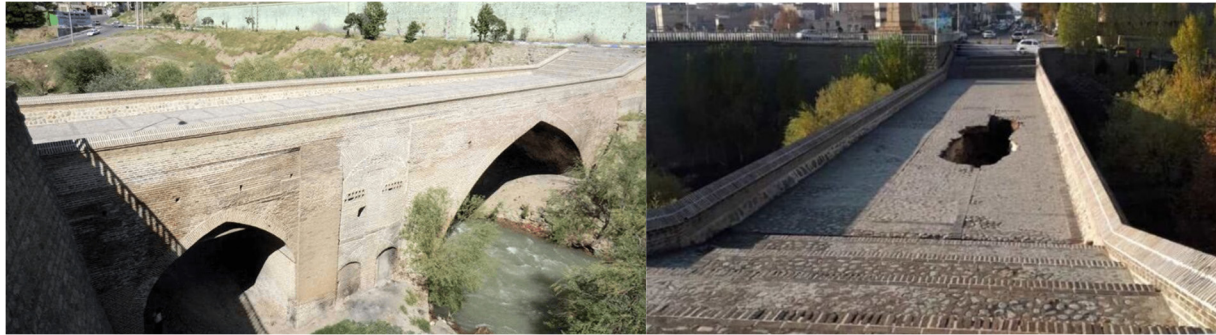
In 2006, a section of the bridge deck collapsed due to falling rocks from the surrounding mountains, but was subsequently repaired. However, the same section collapsed again in 2020 (Figure 3b). Field investigations revealed that during prior restoration efforts, transverse wooden ties supporting the arches were removed, which subjected the arches to increased stress from both dead and live loads. Additionally, cracks and voids in the deck allowed significant infiltration of snowmelt and rainwater. This led to increased dead loads, material erosion, degradation of mortar between bricks, and weakened connections. Over time, these factors destabilized the structure, ultimately causing the deck to collapse again. The recent collapse also suggests improper application of construction techniques during previous restoration.

Further investigations identified outward tilting and deviation from plumb in the bridge's northeastern section, accompanied by cracking. This deformation indicates the potential settlement of the eastern foundation. Flowing river water, containing chemical materials, contributed to the decomposition of the foundations, resulting in material degradation and moisture penetration. Efflorescence is also visible in various parts of the façade, highlighting the structure's vulnerability to moisture-related damage [9].

Figure 3: (a) Shah Abbasi Bridge; (b) Deck collapse in 2020

To ensure a comprehensive restoration, it is imperative to conduct detailed evaluations of the foundation for potential settlement issues. Additionally, traditional construction techniques used in the bridge's original design must be carefully identified and accurately applied during restoration efforts. This approach will preserve the structural and historical integrity of the Shah Abbasi Bridge while addressing the underlying causes of its deterioration.

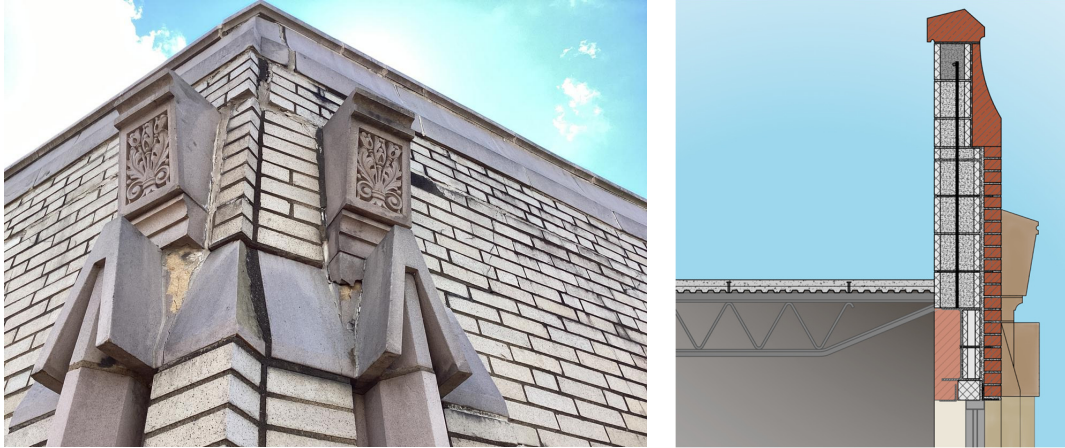
The investigation revealed that the steel angles and plates supporting the building parapets underwent significant corrosion, causing section loss and expansion throughout the exterior of the building. Due to this expansion, the brick masonry parapets at the seventh-floor roof displaced as much as 2.54 cm (1 in) out of plumb (Figure 4a), and the steel elements are no longer adequately supporting the exterior wythe of brick. Significant cracks were noted at the corners of the building (Figure 4a), and the exterior brick debonded from the backup with no positive anchorage to hold it in place. Mortar has pushed outward from the bed joints and, in some locations, mortar fragments have fallen from the face of the building. The brick movement has also caused cracking and spalling of the decorative terra cotta units (Figure 4a), and portions of terra cotta units were observed to have spalled from the façade and fallen from the building to the ground level below. The reinforced gypsum-concrete roof deck also displays substantial deterioration at the roof perimeter due to water infiltration through the parapets.

Figure 4: (a) Parapet damage; (b) Parapet repair section

The root cause of the damage to the parapets was determined to be water infiltration leading to corrosion and expansion of steel embedded in the masonry as well as unaccommodated expansion of the brick due to the lack of expansion joints. Due to the extent of damage to the parapets and roof deck, the decision was made to remove and replace the clay tile backup with CMU instead of repairing the parapets in place and to remove and replace the perimeter of the gypsum-concrete roof deck (Figure 4b). The exterior wythe of brick will be salvaged and reinstalled, and the terra cotta units will be salvaged, repaired, and reinstalled, or replaced with glass fiber reinforced concrete (GFRC) units as necessary.

The retrofit for the roof and parapet was designed in accordance with Chapters 6 and 7. The original design conditions are unknown, so the elements to be disassembled and reconstructed were designed using Chapter 4 per Section 7.4.3.4, *Disassemble and Reconstruct*. In accordance with Section 1.5.7, *New Elements*, the new CMU parapet walls were designed using the Current Building Code. Following Section 7.4.2.1, *Evaluation of temporary conditions from removal of material during repairs*, the structure was evaluated for the temporary condition with the parapet walls and roof deck removed. To avoid creating unstable

conditions, the parapet and roof deck replacement will be done in phases alternating demolition and repair around the perimeter of the building. New dampproofing and flashing will be added within the masonry wall sections in accordance with Section 6.4, *Water Management Improvement*, to limit future water infiltration. Deteriorated steel lintels will be replaced and embedded steel beams to remain will be cleaned and recoated per Section 6.6, *Corrosion Mitigation of Embedded Steel*.
