CORE CONSOLIDATION OF HERITAGE STRUCTURE MASONRY WALLS & FOUNDATIONS USING GROUTING TECHNIQUES - CANADIAN CASE STUDIES

Paul A. Jeffs

Case Study One - Owens Art Gallery, Mount Allison University, New Brunswick

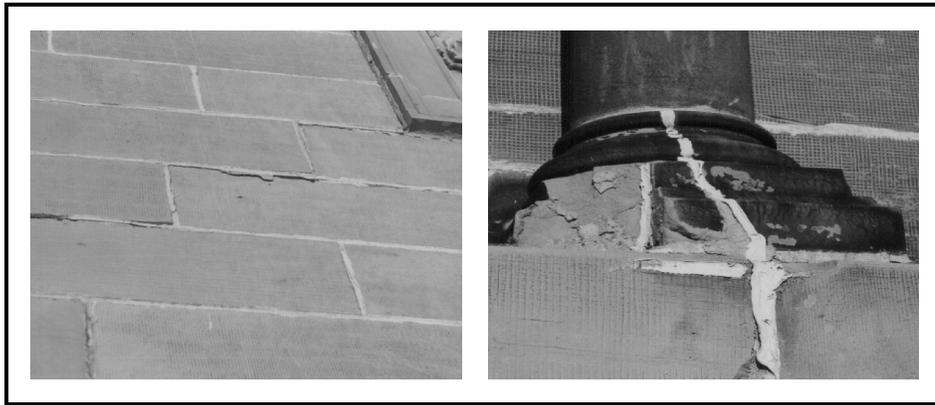
Original construction documents were not available at the time of the investigation of the damage that became apparent during the mid 1990's, but a review of photographs taken during the original construction work confirmed that the foundation walls were constructed as a double wythe with an interior rubble core. Research also confirmed that roof re-construction work was carried out during the early 1970's and subsequently this was proved to have contributed to major damage of the masonry and, in particular, the inner core rubble. It also seems likely that the roof re-construction work caused an increase in the distribution of loads to the outer wythe and this caused cracking and damage to both units and joints.

By 1996, the deterioration and damage caused by the infiltration of moisture through cracks and joints - and the subsequent destabilizing of the inner core rubble - had become extensive. In particular, displacement of stones became evident. (See Photograph 2.) It also appears that the changes in the load distribution through the masonry caused columns supporting the friezes that adorn the front elevation to become over-loaded and this resulted in further damage. (See Photograph 3.)

Photos 2 & 3: Examples of damage caused by the deterioration of inner core rubble

- The relief of load and temporary support of the columns on the south walls during the anchoring, grouting and repointing work; the arrangement consisted of pre-fabricated steel frames between the columns and the use of hydraulic jacks to deflect the loads from the columns; the total required displacement after settlement of the jacks was calculated to be between 0.3 mm and 0.5 mm (0.012 and 0.020-ins); deflection gauges were installed to facilitate monitoring of the load relief and they were held in position until the loads were replaced;
- Below grade waterproofing to contain the grout and improve durability;
- Installation of helical stainless steel masonry ties between the two outer wythes to provide temporary restraint during grouting, and to improve the composite action of the masonry;

- Repair of damaged units using a proprietary mortar designed for heritage structure applications;
- Raking out deteriorated or inappropriate mortar and other materials within the mortar joints and back-pointing with a lime/cement based mortar to contain the grout during restoration work. The front of the joints were left open for about 25-mm (1-in) to facilitate final repointing;

- Water-flushing the inner core rubble using warm water and low pressure to remove any disintegrated binder so that the grout could subsequently be pumped at reduced pressures. (See Photograph 6.) Two way radios were used between the operator and a watch-person within the gallery to ensure that leakage to the interior did not cause damage to finishes, etc.

- Grouting of the voids within the core with a cellular foamed cement grout designed to be compatible with the requirement for consolidation and stability without excessive stiffness;

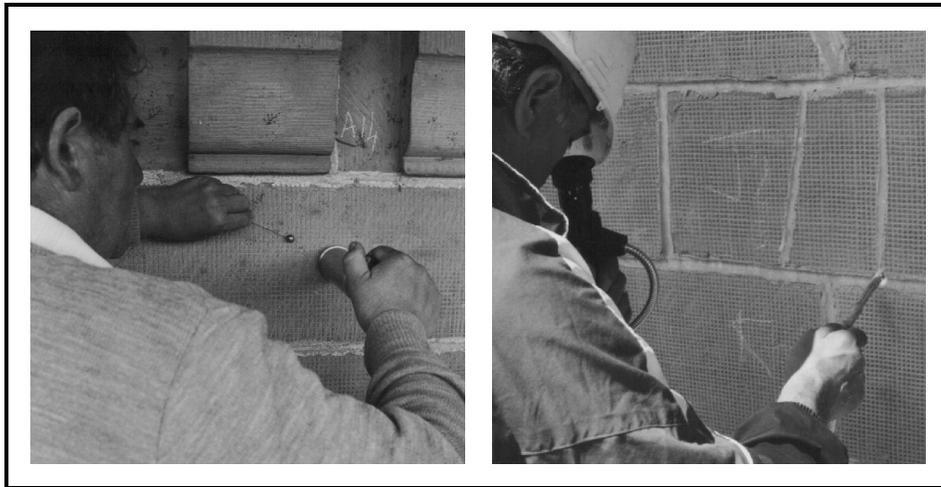
- Non-destructive testing to confirm the presence and extent of hidden voids, including impact-echo testing, and fibre-optic inspections; (See Photos 4 & 5)
- A structural evaluation to provide data required for the restoration strategy.

Photos 4 & 5: Using impact-echo (left) and fibre optics to investigate the condition of the inner core.

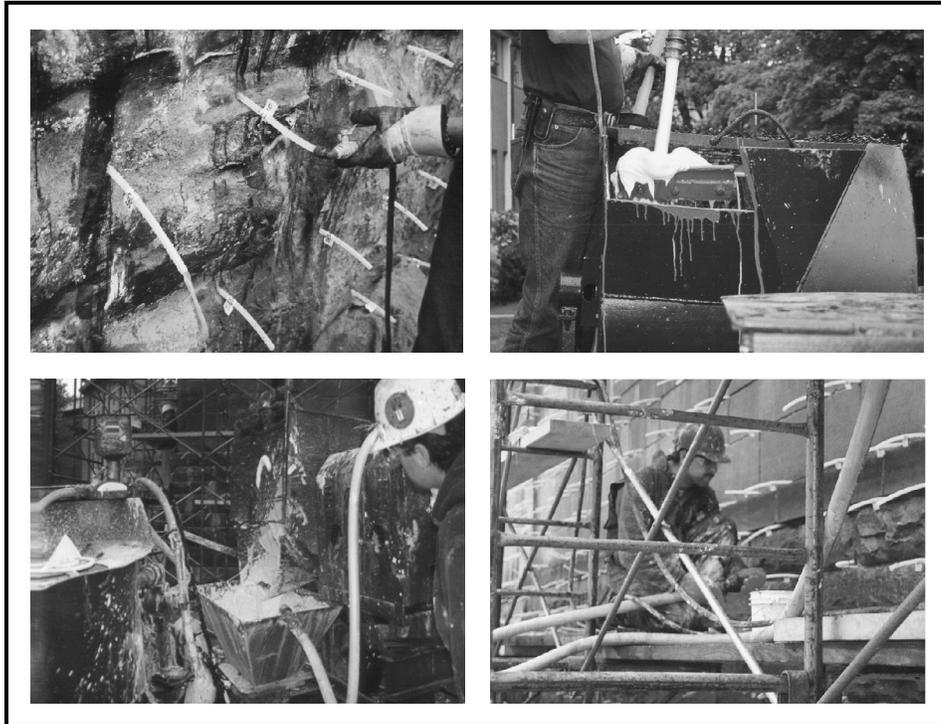
Photos 8: (Top Left) Flushing the core with warm water. Photo 9: (Top Right) Pumping foam into mortar mixer. Photo 10 (Bottom Left) Transferring cellular grout to pump hopper. Photo 11: (Bottom Right) Injecting cellular grout into inner core rubble.

The liquid cellular grout, which was designed to have a wet density between 720 and 800-Kg/m³ (45 and 50-pcf), was produced by blending a foam into a 0.45 water/cement ratio grout. A methylcellulose-type admixture was mixed within the cement/water grout to provide thixotropic properties to the plastic grout and minimize leakage to the interior through cracks, gaps, etc. 28-day compressive strengths were typically between 5 to 7 N/mm². (725 to 1015 psi) To produce the foam, a proprietary surfactant-type admixture was diluted in water and forced through a nozzle under pressure using a purpose designed pump. A high-shear colloidal mixer was used to mix the cement/water grout which was then transferred into a standard spiral-blade mortar mixer. After the foam had been blended into the grout, (See Photographs 7 & 8) the final mixture was injected into the core using a standard Moyno pump fitted with 50-mm (2") diameter lines. (See Photograph 9.) The nozzle end was fitted with a pressure gauge and a return line to

permit the nozzleman to control the flow of grout and pumping pressures. Above grade level the grout contained white cement to reduce the level of soluble salts that could subsequently leach to the surface and contaminate the masonry units. An estimated 25 cu.m. (900 cu.ft.) of grout was injected into the inner core rubble voids, which represented approximately 7.5% of the total volume of masonry.

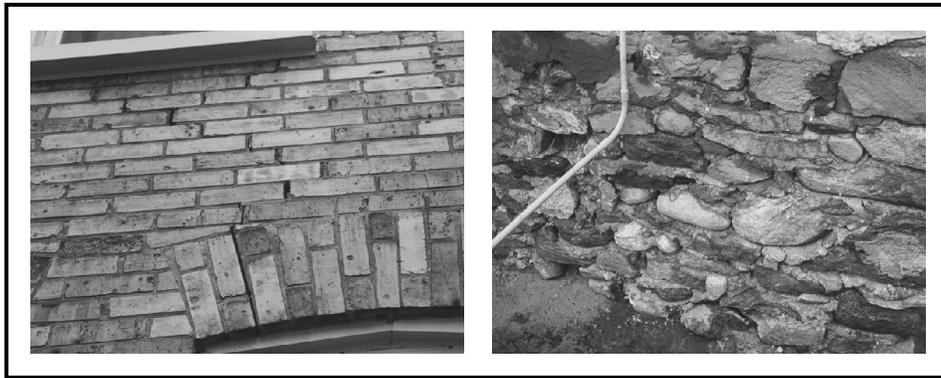
Constructed in 1895, Saint Louis Convent in Waterloo is a brick masonry structure supported on a double wythe foundation wall. Over the years, excessive step-cracks occurred within the brick masonry walls at many locations - usually adjacent to windows. (See Photograph 12.) Lack of available funds precluded a detailed investigation but a preliminary visual study indicated that the most likely cause of the cracking was differential settlement/movement of the foundation walls - most likely due to destabilisation of the inner core rubble. This could be confirmed by the condition of the masonry at and just below grade level, the knowledge that the below grade portions of the walls had not been waterproofed, and the presence of debris within the basement that was most likely disintegrated core rubble binder. The poor condition of the below grade foundation walls was confirmed during the subsequent restoration work. (See Photograph 13.)

Photo 12: (Left) Cracks caused by deterioration of inner core rubble. Photo 13: (Right) Condition of below grade foundation wall.

- To provide the required restraint during grouting and a better composite action between the two wythes, helical stainless steel ties were installed into the basement interior. In view of the tough nature of the mainly granite stones, the ties were epoxy-resin grouted “front and back”.

- The below grade portion of the foundation wall masonry was exposed, waterproofed and back-filled - both to contain the grout and to provide improved protection.

- The masonry joints within the above grade portion of the foundation walls were cut-out and repointed using a prepackaged lime-based heritage restoration mortar. (Hard cement-based mortar was also removed from the face of the stone masonry units.)

- Holes were drilled into the inner core rubble from the inside. Warm water was used to flush out disintegrated binder from the core, and the voids were grouted using similar techniques to those already described for the previous case study. Almost 6.0 cu.m. (200 cu.ft.) of grout was calculated to have been injected, which represented about 10% of the total volume of masonry.

- The cracks within the brick masonry walls were “stitched” using the helical stainless steel masonry ties. The ties were “dry-fixed” into smaller diameter pilot holes first drilled to the required depth. The holes were drilled at 45° angles through the mortar joints to intersect the cracks roughly at their mid-point.

- The open joints within the brick masonry were then cut-out and repointed using a prepacked heritage restoration masonry mortar, selected to blend with the existing mortar.

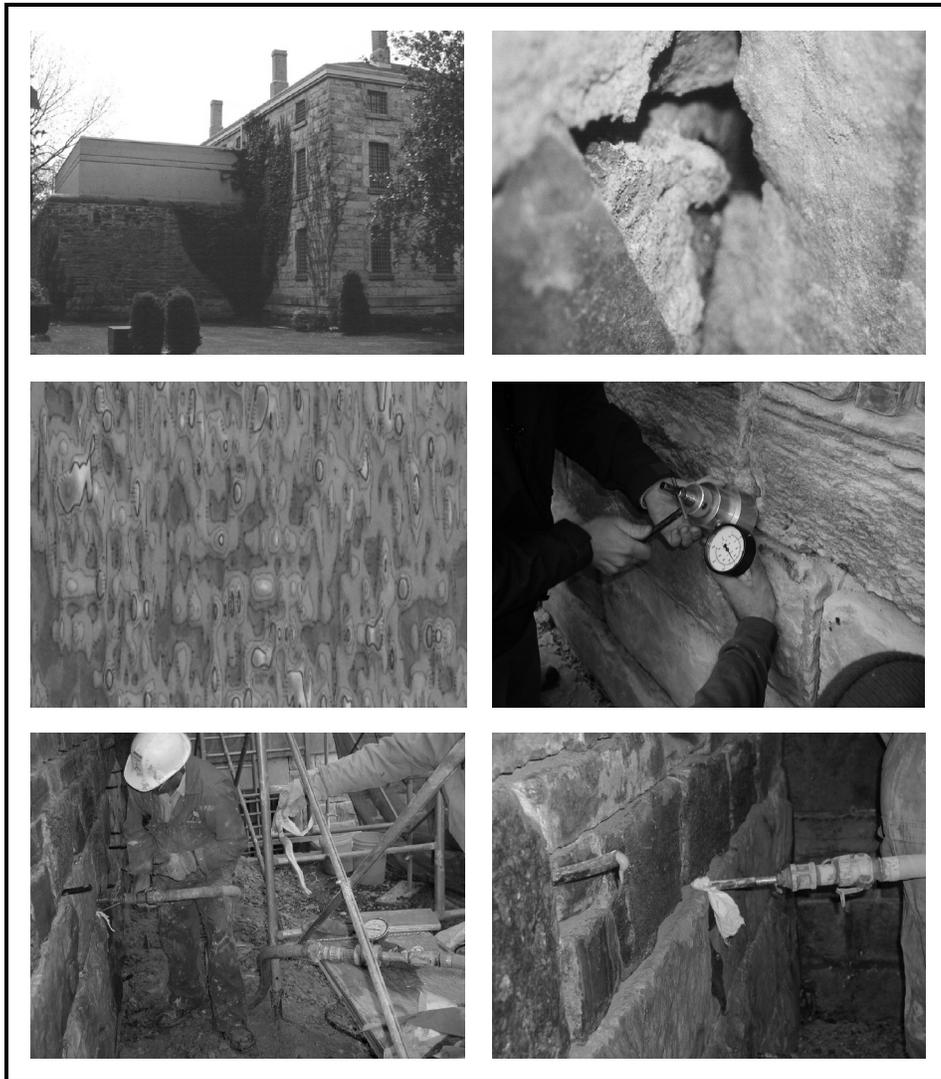
During the old mortar cutting out operations loose stones and the presence of disintegrated mortar indicated that the inner core rubble was in a poor condition and further investigation was determined necessary. (See Photograph 15.) The investigation consisted primarily of a survey using Ground Penetration Radar (GPR) techniques which revealed the presence of considerable voidage. It is believed that this was the first time that the technique has been used for this purpose in Canada and the results provided by computer-generated contour mapping of the results were extremely valuable. (See Fig. 1.) The mapping of the voids and suspected loosely bound rubble facilitated the installation of the injection ports and the concentration of grout at key locations.

Photo 14 (Top Left) Former County of Peel Jail - the grouted courtyard wall is to its left. Photo 15 (Top Right) Example of inner core rubble deterioration after removal of stone masonry unit. Figure 1 (Middle Left) Computerized contour image produced by GPR - The darker areas represent solid masonry. Photo 16 (Middle Left) Pullout testing a masonry tie. Photo 17: (Bottom Left) Pumping cellular grout through an injection port. Photo 18 (Bottom Right) Contact is made between ports.

Helical stainless steel masonry ties were first installed to provide restraint against grouting pressures and to improve the composite action of the restored masonry. Tests were first carried out to ensure adequate pull-out load could be achieved. (See Photograph 16.) The grout and grouting techniques were similar to those described for the previous case studies. (See Photograph 17.)

About 2 cubic metres (70 cubic feet) of grout was used - approximately that calculated to be required from the data provided by the GPR survey - representing about 6% of the total masonry volume. Good flow within the rubble was achieved through interconnected voids and positive contact was made between most of the ports. (See Photograph 18.)
