IN-PLANE SEISMIC BEHAVIOUR OF SLENDER REINFORCED MASONRY SHEAR WALLS: EXPERIMENTAL RESULTS

B. Robazza¹, K.J. Elwood², D. L. Anderson³ and S. Brzev⁴

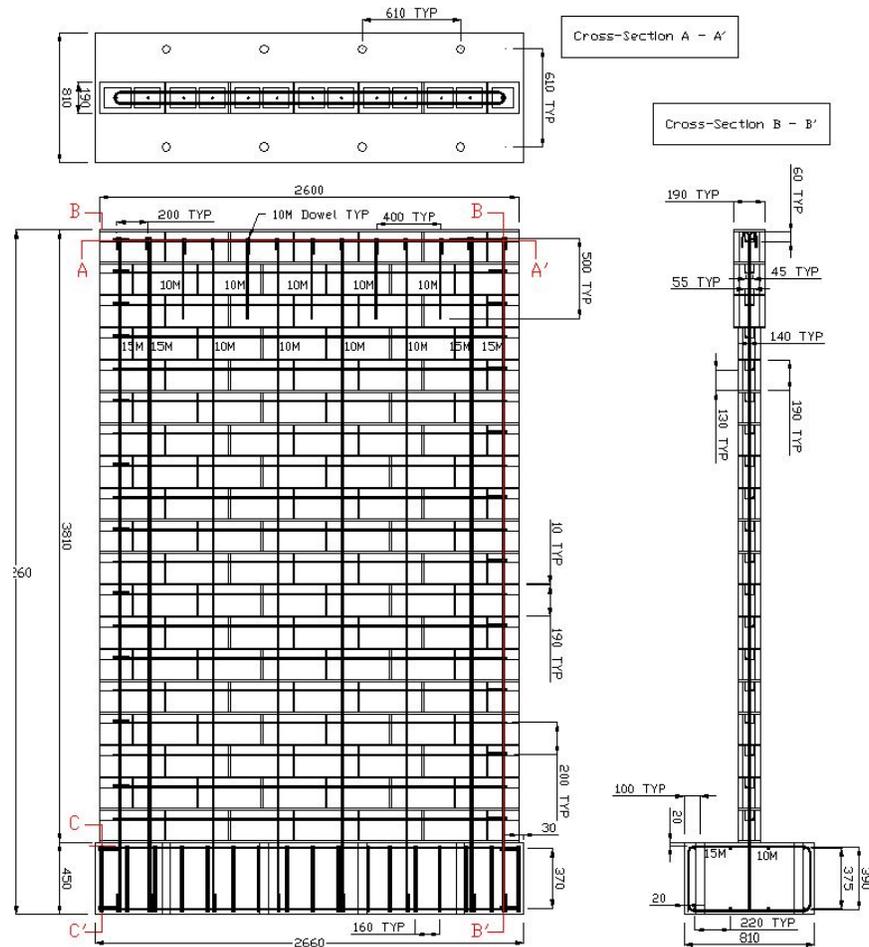
Figure 1: Wall specimen - dimensions and reinforcement details

Two identical full-scale wall specimens were constructed by a professional mason for the Phase 2 experimental study. The specimens are 2.6 m long and 3.8 m high (equivalent to 19 courses of masonry). The specimens were constructed using standard concrete blocks (400 mm length x 200 mm depth x 140 mm thickness) laid in running bond, and Type S mortar was used for face shell bedding. The vertical reinforcement consisted of one 15M reinforcing bar concentrated in the exterior two cells on each wall end, plus 10M bars spaced at 400 mm on centre along the wall length; this corresponds to the reinforcement ratio of 0.33%, which is similar to that used in Canadian design practice. The reinforcement was continuous up the wall height (no lap splices). The horizontal reinforcement was placed in bond beam blocks and consisted of 10M bars at 200 mm spacing (each course); this corresponds to the reinforcement ratio of 0.36%. Alternating 180° hooks were provided at the ends of horizontal bars. The specimens were fully grouted with a commercially available regular coarse grout mix. To ensure the wall stability during the construction, the grout was pumped in two lifts (one-half height and full height). The top three courses were constructed using wider, 190 mm blocks, and 10M vertical dowels as well as an additional horizontal 10M bar were provided to prevent sliding shear failure. The specimens were supported by 810 mm x 450 mm x 2660 mm (width x height x length) heavily reinforced concrete footing, with all wall vertical reinforcement fully developed in the footing. Wall specimen dimensions and the reinforcement layout are presented in Figure 1.

The specimen height/length (h/l) ratio of 1.5 was chosen to ensure flexural behaviour characterized by the formation of plastic hinges at the base of the wall, a prerequisite for the out-of-plane instability. The wall height/thickness (h/t) ratio of 27, significantly higher than the upper CSA S304 limit, was chosen to increase chances for out-of-plane instability. The vertical reinforcement distribution was determined considering the criterion to maximize the length of the compression zone, and the corresponding strains in concentrated 15M reinforcing bars at the wall ends. The capacity design approach was followed to avoid the possibility of shear failure in the specimen.

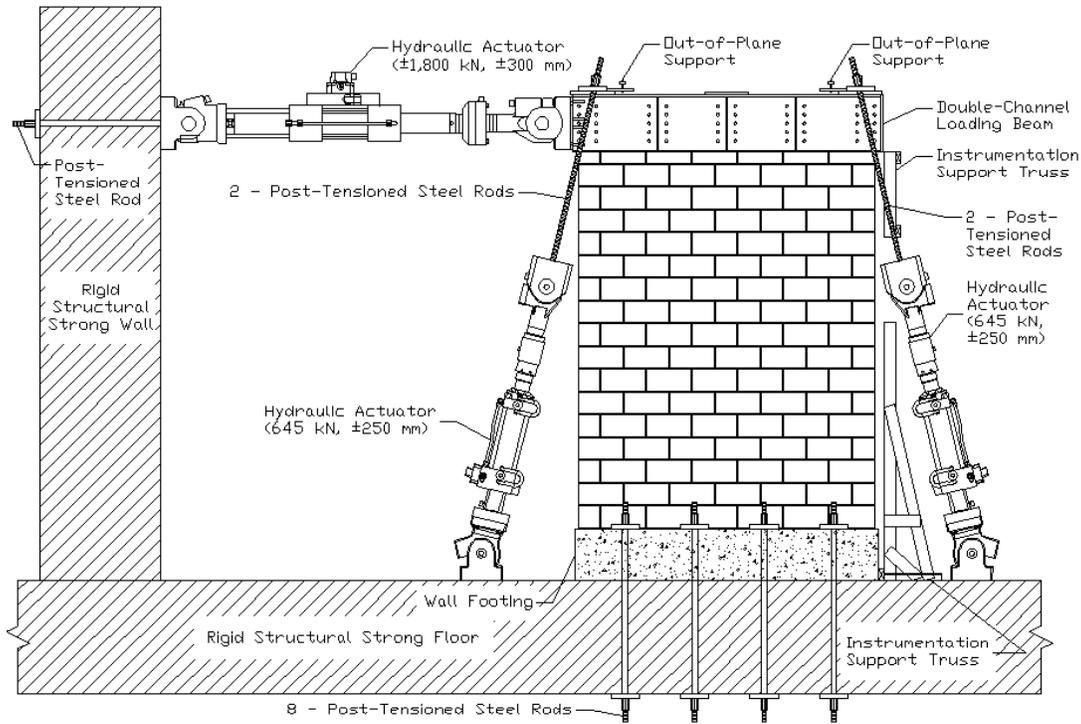
Figure 2: Test Setup

The test setup was custom designed for this study and it is shown in Figure 2. The top of the specimen was connected to a double-channel steel loading beam through vertical rods. The loading was applied through one horizontal and two vertical MTS actuators attached to the loading beam. One end of the horizontal actuator (capacity 1000 kN, ± 343 mm stroke) was bolted to a set of ends plates welded to the loading beam, with its centreline aligned at the second highest course of masonry, and the other end was attached to the strong wall in the UBC Structures Laboratory. Two "near vertical" actuators (capacity 645 kN, ± 305 mm stroke) were inclined at an approximately 13° angle with regard to vertical to reduce the size of the loading beam. These actuators were connected to the loading beam by two high-strength post-tensioned steel rods each through bearing plates at the ends of the loading beam. The footing was attached to the laboratory's strong floor by post-tensioning to produce a rigid base connection. Out-of-plane lateral displacements at the top of the specimen were restrained by two adjustable steel arms connecting the support columns and the top of the loading beam through pin connections.

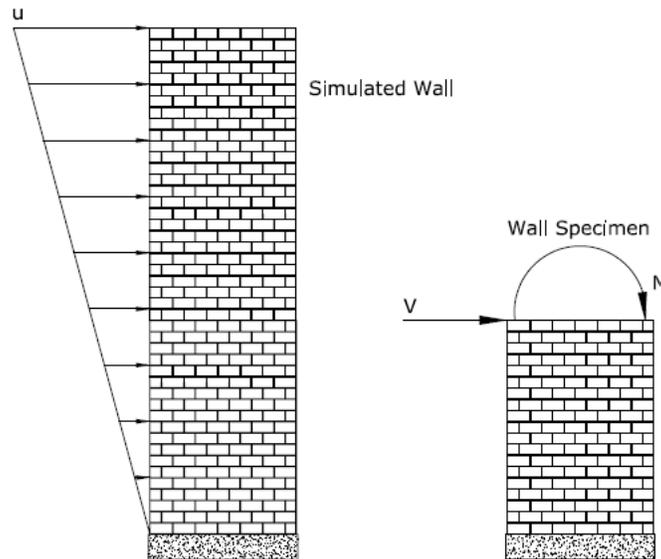
Figure 3: Applied lateral loads on the simulated wall and equivalent loads on the wall specimen

The objective of the test setup was to simulate the effect of seismic loads on the lower portion of a 9 m high wall in a three-storey building (referred to as simulated wall in the paper). The vertical compression loading was held constant at 660 kN (corresponding to axial compressive stress of $0.086f_m$). Lateral load on the specimen was applied through the horizontal actuator in combination with the net horizontal load from the sum of the two vertical actuators. The overturning moment representing the loads in the upper stories of the simulated wall was created by combined the effects of lateral and vertical loads of the actuators. The loads in the vertical actuators were slaved to the load from the horizontal actuator by a linear relationship derived from equilibrium equations relating the simulated wall to the wall specimen. This relation is demonstrated in Figure 3.

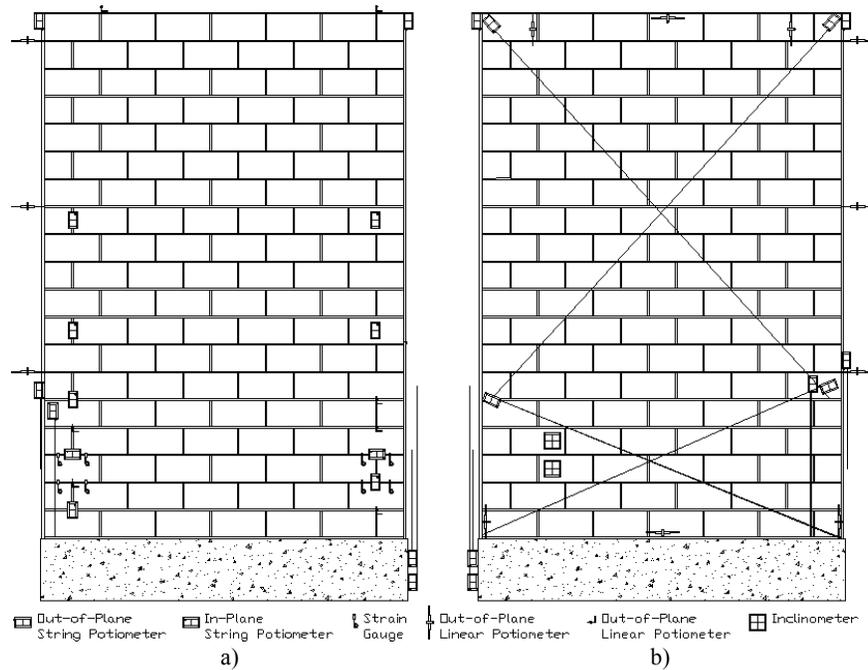
Figure 4: Test Instrumentation: a) West face, and b) East face

Loads and deformations in the specimen were monitored during the testing by a data acquisition system (Digital Equipment Station) with 53 channels. The instrumentation consisted of 21 string potentiometers and 16 linear potentiometers, which were used to measure vertical in-plane, horizontal out-of-plane, and diagonal in-plane deformations of the wall specimen, as shown in Figure 4. The configuration of these instruments created an effective strain rosette required to distinguish between flexural and shear deformations. Eight linear potentiometers were used to capture the out-of-plane displacements in the plastic hinge region, in-plane lateral displacements, uplift at the wall toes, base slip, slipping of the loading beam, and finally any lateral

displacements of the support columns due to potential loading from the out-of-plane supports. In addition, two inclinometers were utilized to capture the out-of-plane rotations of the plastic hinge region and 8 strain gauges were monitored strains in the 15M reinforcing bars at the wall ends.

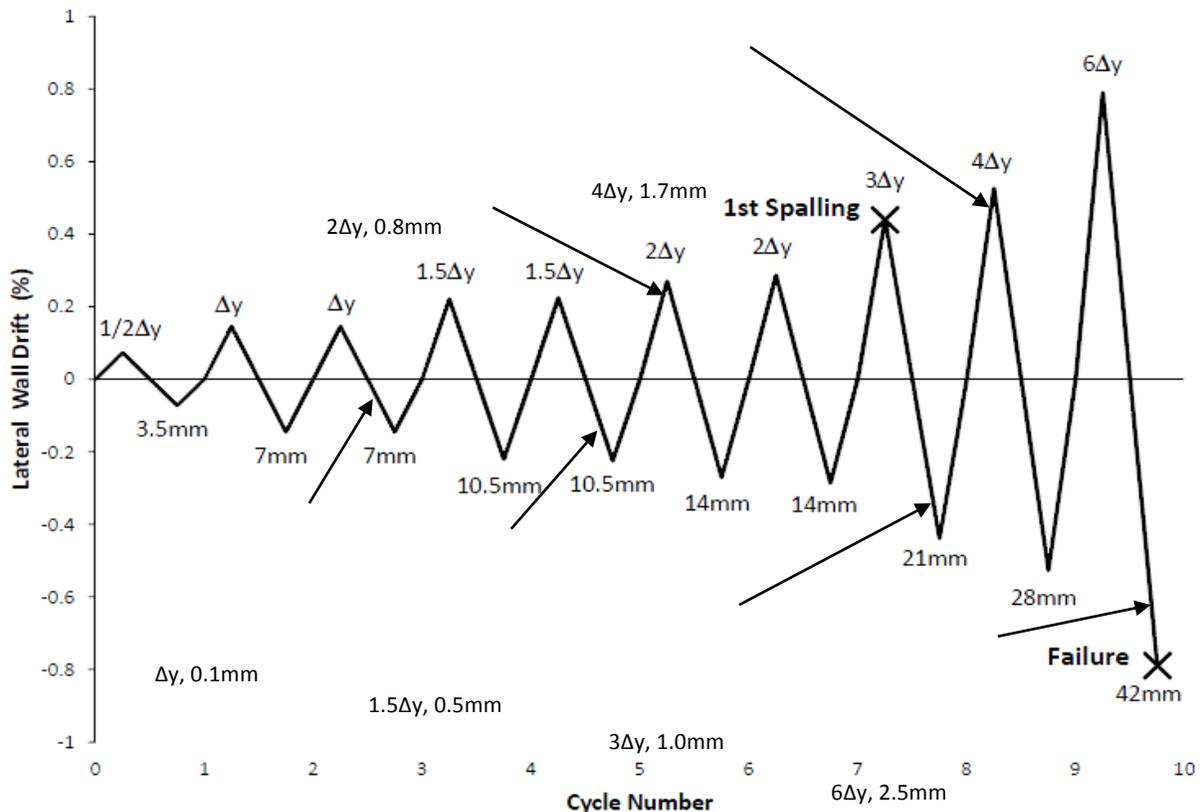
Figure 5: Loading protocol showing lateral wall drift on the y-axis, target actuator displacements and the corresponding maximum crack widths for each photo

The loading protocol is shown in Figure 5. The testing started after the initial vertical compression load of 660 kN had been applied by the near vertical actuators. The loading protocol was displacement-controlled, and it consisted of one or more cycles of incrementally increasing lateral displacements. The target displacement for each cycle was expressed in terms of Δ_y , the yield deflection in the outermost vertical reinforcing bars in the wall. The Δ_y value of 7 mm was determined by analysis and confirmed by the test data. It is important to note that the target displacement levels shown in Figure 5 were used by the controls during the testing; however, somewhat different displacement values are shown on the force-displacement hysteresis curves in Figure 10. This difference is due to gap closing within the test setup and the deflection of the strong wall.

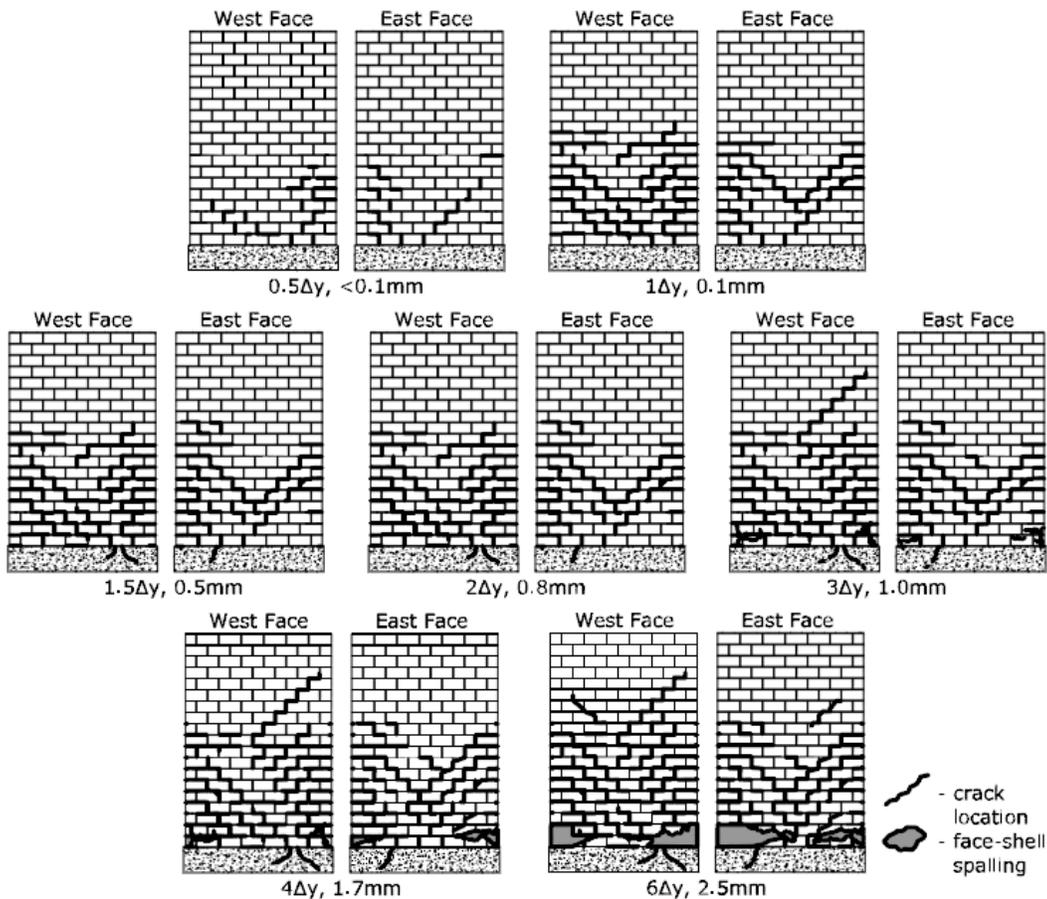
Figure 6: Cracking patterns at increasing target displacement levels

The specimen behaviour was elastic during the initial displacement cycles ($0.5\Delta_y$ and Δ_y). A number of cracks were observed at the Δ_y displacement level. The cracks were mapped at the end of each half-cycle (defined as the point of zero load). The cracks were located along the lower half of the wall specimen, and were mostly in the form of minor stepped cracks along the bed joints which originated at the wall ends. The maximum crack width of approximately 0.1 mm was observed along the bed joints. Figures 6 displays the crack pattern recorded during the test.

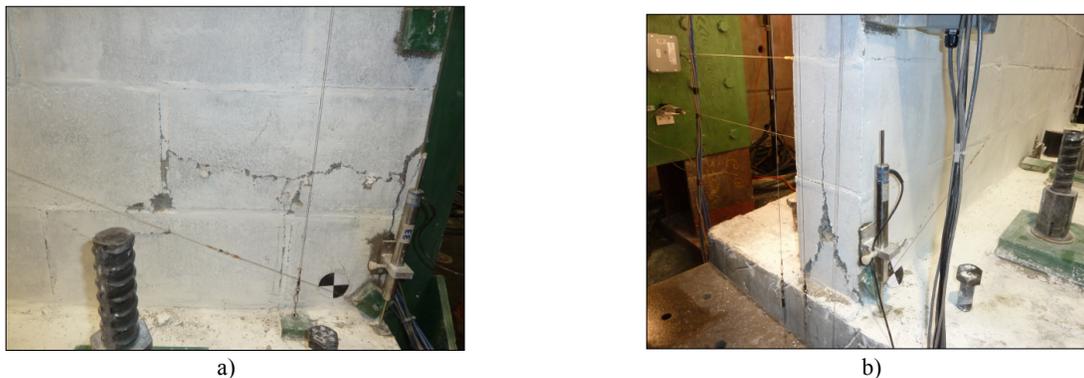
Figure 7: Cracking at the target displacement $3\Delta_y$: a) North toe, and b) South toe

During the following cycle, the specimen was subjected to $3\Delta_y$ target displacement in the North direction. Extensive spalling developed at the North wall toe at the end of the cycle, as shown in Figure 7. The compression damage extended up the bottom two courses and resulted in a drop of 50kN (20% of peak) of the lateral load. The specimen behaviour was similar during the next half-cycle when the $3\Delta_y$ target displacement was applied in the South direction. The South wall toe also experienced face shell spalling, and the load dropped by approximately 50kN (20% of its respective peak) Cracks opened to a maximum width of approximately 1 mm along their horizontal lengths, and two new sets of step cracks were observed at the wall ends.

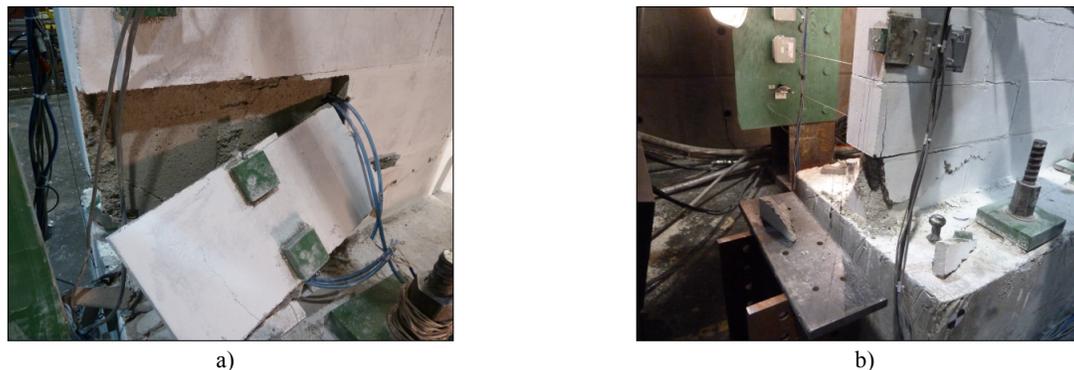
Figure 8: Specimen damage at the target displacement $4\Delta_y$: a) North toe, and b) South toe

half. There were two instances of diagonal cracks extending through the block units (see Figure 8), however most of cracking took place along the mortar joints. Maximum crack widths of 0.5 mm were observed at several locations at this stage.

Spalling at the wall toes became more extensive during the target displacement $4\Delta_y$ cycle, as shown in Figure 8. The wall compression zone was shifted toward the centre because the toes crushed over the two bottom courses, and the vertical reinforcing bars at the wall ends were exposed. It was observed that the end reinforcing bars buckled under compression and

straightened under tension. The plastic hinge became apparent over approximately a 800 mm height starting at the wall base (bottom 4 courses). Cracking along the bed joints at the North and South wall ends extended up the lower 11 courses. Several major horizontal cracks were observed on the West and East wall faces, with the maximum widths of up to 1.7 mm.

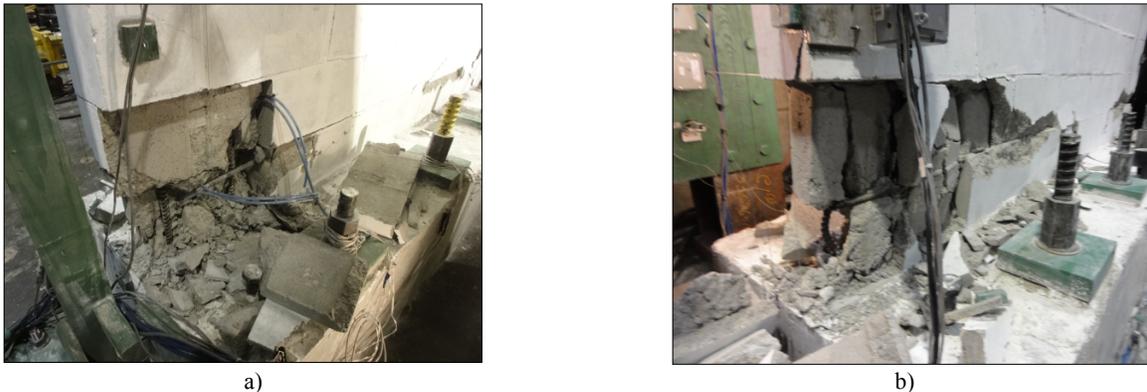
Figure 9: Specimen failure at the target displacement $6\Delta_y$: a) North toe, and b) South toe

The final target displacement load cycle of $6\Delta_y$ in both the North and South directions concluded the test. Loss of integrity of the wall toes became very significant at this stage, as shown in Figure 9. The specimen effectively lost the load-bearing capacity of approximately 1000 mm of wall length (nearly 40% of the overall wall length) due to the compression failure at the North end. It was observed from the spalled face shells that the interior face shell surface in contact with the grout was clean and smooth, which is a sign of poor bond. During the same half-cycle, the buckled reinforcement at the South wall end nearly straightened under tension. Cracks along the horizontal bed joints opened to a maximum 2.5 mm width, while the vertical crack widths remained within the 0.3 mm range. Besides additional large cracks at the wall toes, a new stepping crack formed at the compression end in the upper portion of the wall. The specimen demonstrated similar behaviour during the subsequent displacement half-cycle in the South direction. At this stage, crushing occurred in the South wall toe subjected to compression, and the reinforcement at the North end straightened under tension. Near the end of this half-cycle, a major drop in the load of 115 kN (roughly 60% of this cycles peak load) was observed. This effectively constituted failure of the wall specimen. After unloading to zero lateral load, the presence of vertical loads caused crushing of the specimen near the base. It is estimated that an effective loss of the load-bearing capacity at the wall toes over five or more block lengths resulted in excessively high compressive stress (approximately $0.5f_m$) at the centre of the wall.

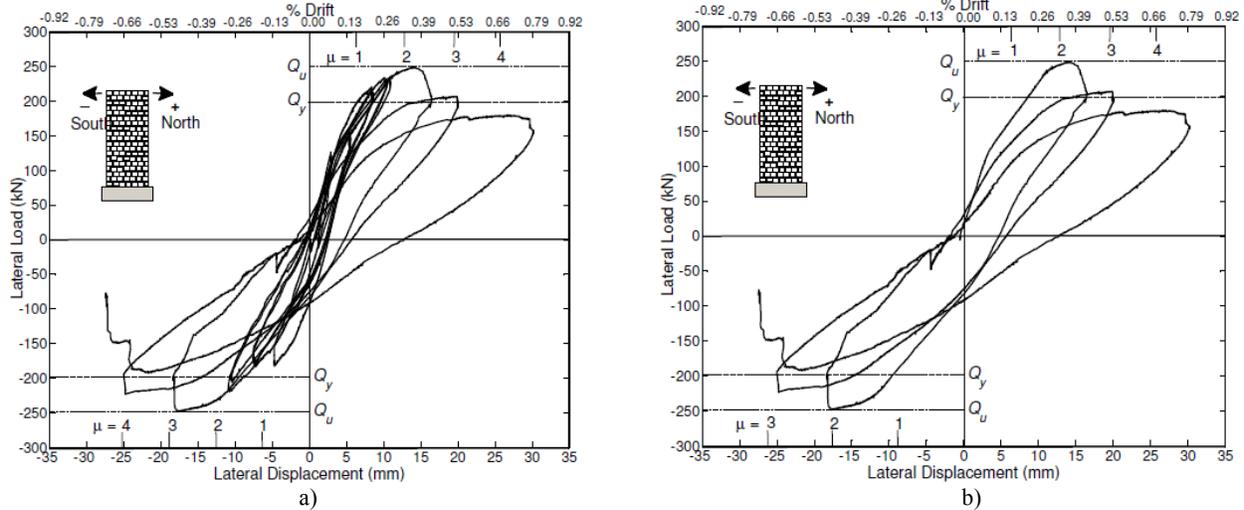
Figure 10: Lateral load-displacement hysteretic curves: a) full test, and b) last three cycles

The load-displacement hysteresis curves are shown in Figure 10. The curves were obtained by plotting the recorded lateral forces from the actuator load cell versus the displacement at the 18th course. Figure 10a) demonstrates that the specimen displayed stable and relatively symmetrical hysteretic behaviour until the maximum load, Q_u , of 250 kN had been reached (corresponding to the displacement cycle $3\Delta_y$). The corresponding drift ratio was 0.36%, and the displacement ductility ratio (μ) was 2.1. Note that the equivalent yield load, Q_y , was approximately determined from the hysteretic behaviour and supported by the strain gauge data. Figure 10b) shows the final three load cycles before the failure. It can be seen that a 20% drop in load occurred at the 0.52% drift level, and the corresponding μ value was 3.1. The maximum ductility ratio reached during the test was 4.6, and the corresponding drift ratio was 0.79%. Figure 11a) shows the hysteresis curves for overturning moment versus lateral displacement, which are very similar to the curves

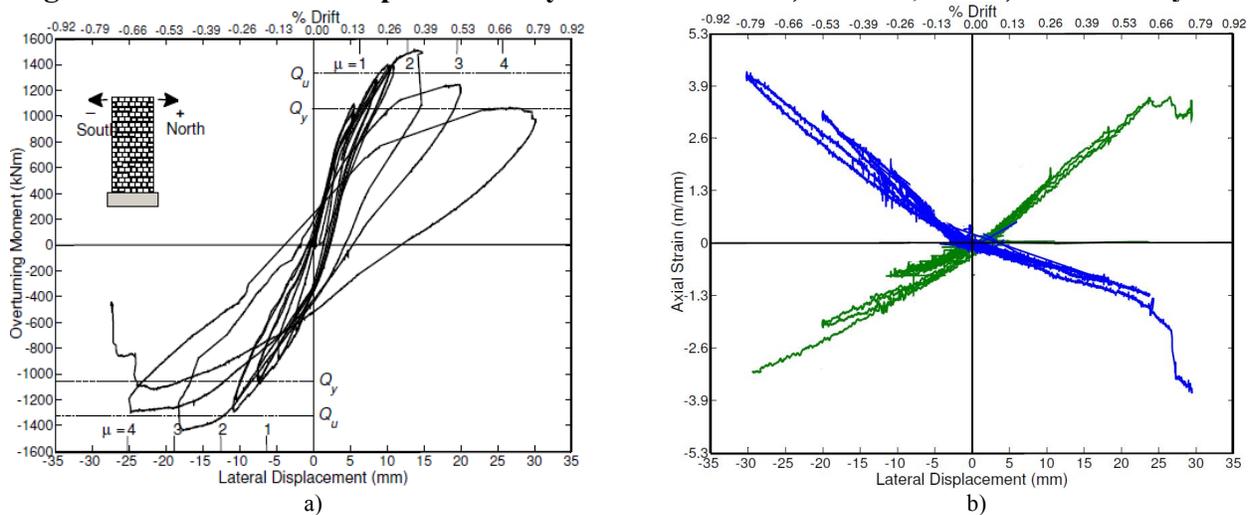
Figure 11: Hysteretic response of the specimen: a) overturning moment versus lateral displacement, and b) average vertical strains at the wall end zones

shown in Figure 10a). Figure 11b) displays average strains in the exterior vertical reinforcement. Although the strain gauges detected steel strains on the order of 0.02%, corresponding to the displacement $10\Delta_y$, average end zone vertical strains calculated from the recorded displacements indicated much smaller average strains of $2\Delta_y$ over the entire wall height. However, it must be noted that the average vertical strain was highly concentrated at the bed joints.
