15th Canadian Masonry Symposium Ottawa, Canada June 2-5, 2025

A Design-Assist Approach to Laser Cleaning of Stonework at the Centre Block, Parliament Hill, Ottawa.

David Edgarⁱ and Kate Westburyⁱⁱ

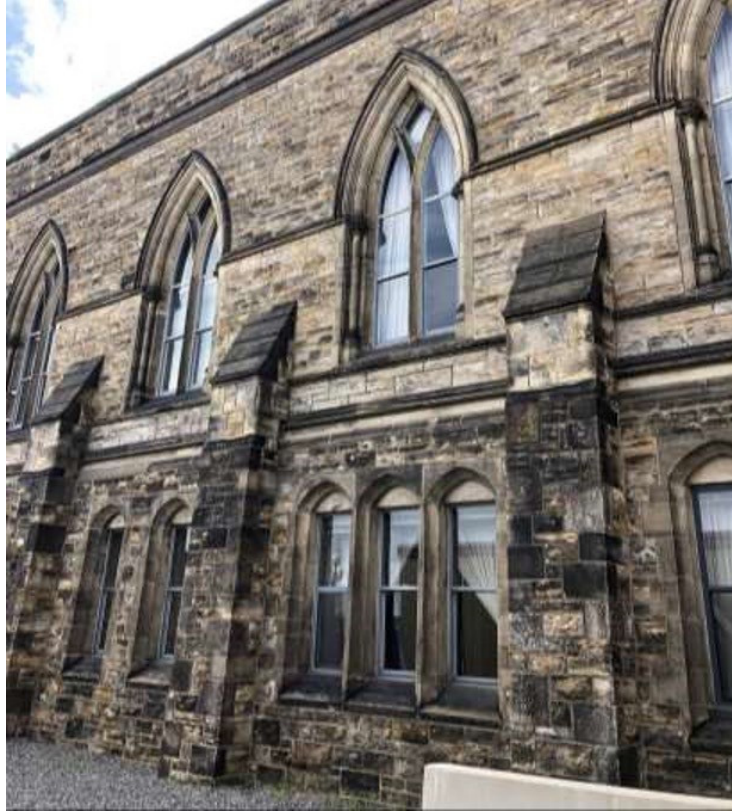
Nature of soiling on CB's exterior

The purpose of cleaning the stone is to remove the crust which is caused by atmospheric soiling. This crust impedes the movement of moisture and associated soluble salts, which can cause an accumulation of recrystallized salts under the surface of the stone (sub-florescence), leading to mechanical damage, surface exfoliation and material loss. Removing the crust will unclog the stone pores, thereby increasing the water vapour transmission properties of the stone so it can 'breathe'. Moisture will always pass through porous material (such as sandstone) which is why it is important for the building to maintain its ability to lose water. Laser cleaning can help achieve this goal. However, over-cleaning must be avoided as the resultant loss of surface material will accelerate damage to the stone.

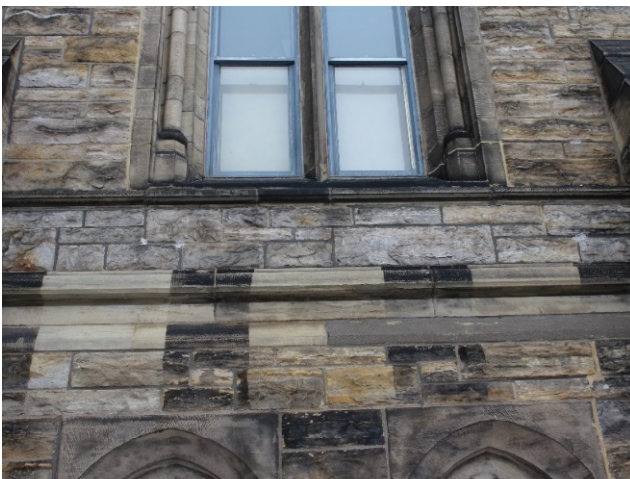
Proponent No.1: Mock-ups of West Block contractor and laser for assessment on CB

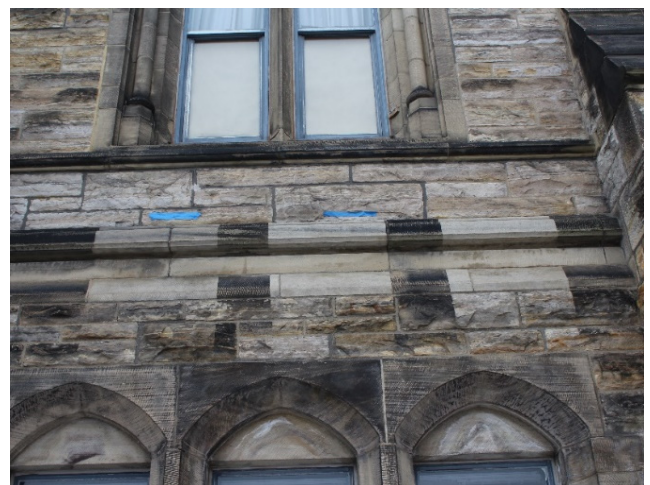
Proponent No.2: Mock-ups by Wellington Wall contractor for assessment on CB

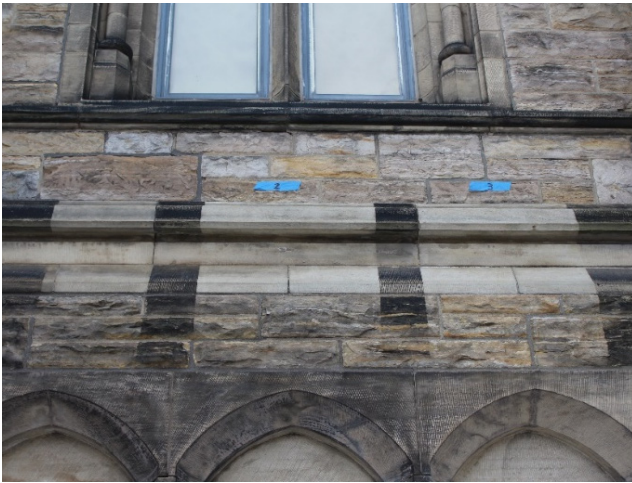
Proponent No.3: Mock-ups with Wellington Wall laser for assessment on CB

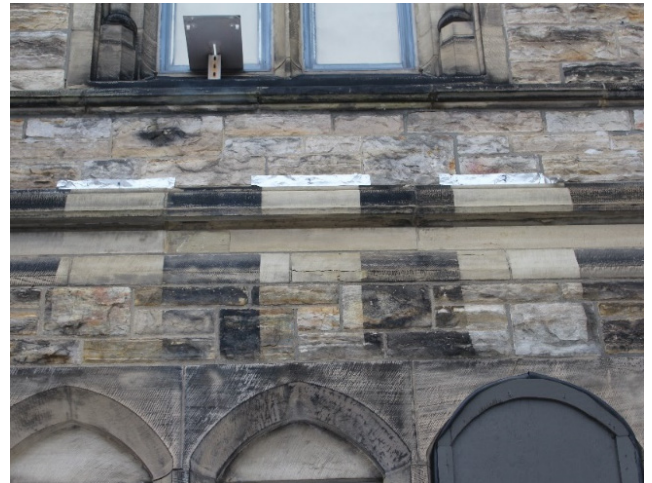
Proponent No.4: Mock-ups of East Block and Canada Four Corners contractor and laser for assessment on CB

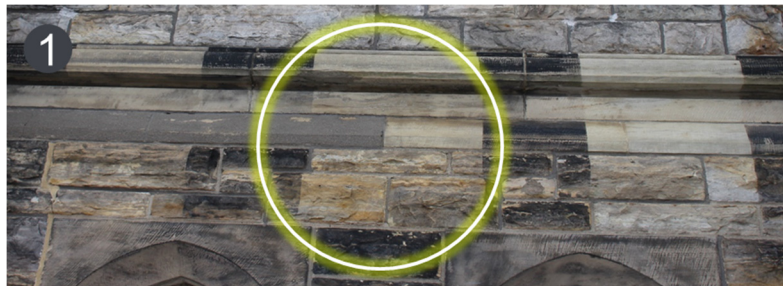
Proponent No.1: West Block contractor and laser, selected by team, and considered acceptable level of clean

The following two samples were considered to meet the project design parameters:

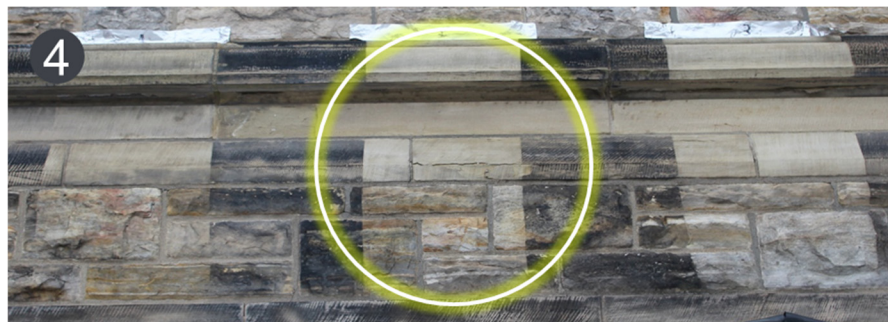
Proponent No.4: East Block and Canada Four Corners contractor and laser, selected by team, and considered acceptable level of clean
