**15<sup>th</sup> Canadian Masonry Symposium**  
**Ottawa, Canada**  
**June 2-5, 2025**

## **Seismic Performance of Traditional Brick-Mortar and Interlocking Compressed Earth Brick Walls under Cyclic Loading**

**Junaid Shah Khan<sup>i</sup>, Azam Khan<sup>ii</sup>, and Tatheer Zahra<sup>iii</sup>**

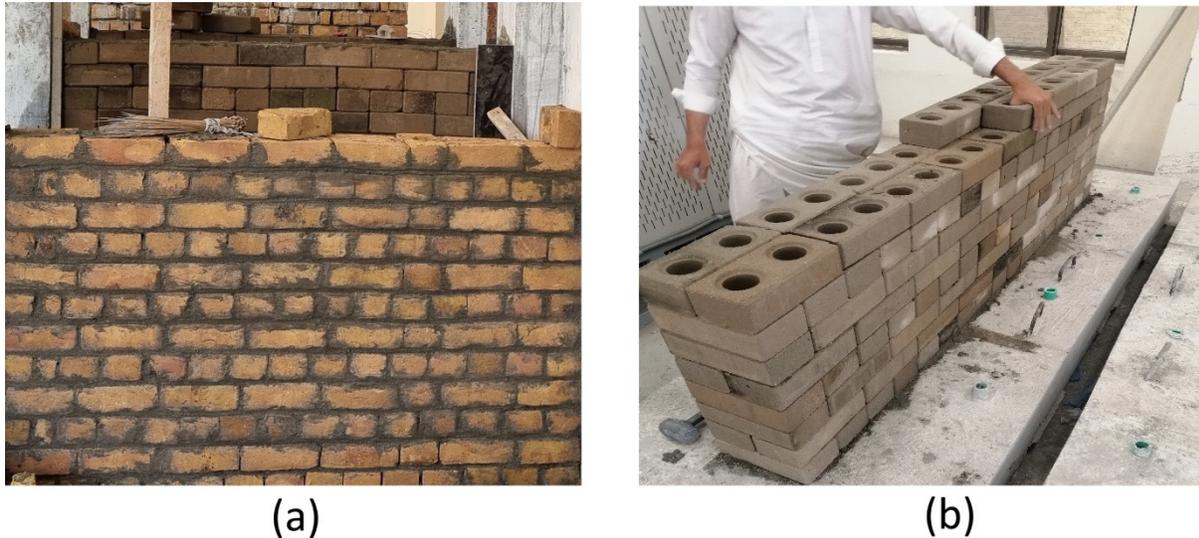
**Fig. 1. Masonry typology (a) traditional masonry wall (b) ICEB masonry wall under construction**

This study offers a comparison of two types of masonry walls: traditional burnt brick mortar-bonded masonry and mortarless grouted interlocking earth brick masonry shown in Fig. 1. The structural performance of these systems is evaluated under lateral cyclic loading tests, given the seismic vulnerability associated with traditional masonry.

High-quality solid burnt clay bricks refer as first-class brick, commonly used in Pakistan and measuring 220 mm × 105 mm × 73 mm, were used to construct the traditional mortar-bonded masonry specimen for this study. A brick laying method of English bond was employed and the joints were mortared with a 1:5

cement sand ratio, with an average joint thickness of 12.5 mm. This wall had dimensions of 2490 mm in height, 2134 mm in length, and a thickness of 220 mm. The RC band beam in the reinforcement configuration is situated 1524 mm above the base of the wall, had a depth of 152.4 mm, and contained two Grade-60 #3 bars. The beam acts as mid-height reinforcement, enhances the shear strength of the wall, contributing to improved seismic performance. To facilitate the lateral load application through the actuator, a loading beam was constructed at the top of both walls. The RC beam having a depth of 254 mm was reinforced with a total of six #4 bars as main reinforcement and #3 stirrups spaced at 76.2 mm near supports and 152.4 mm on center elsewhere.

The ICEB specimen was constructed using a double leaf interlocking bonding pattern system. Each unit of ICEB had dimensions of 254 mm in length, 127 mm in width, and 81 mm in depth, comprising two cylindrical holes each of 58.7 mm diameter, strategically placed to allow for vertical grouting and reinforcement. The wall measurements were 2512 mm in height, 2159 mm in length, and a thickness of 254 mm. The ICEBs were arranged in a pattern that alternated headers and stretchers across successive rows. This layout was chosen specifically to lock the two leaves of the wall together, significantly enhancing the structural stability [18]. Vertical cavities were filled with a grouting mixture of 1:2:4 cement sand and coarse aggregates of size 12.7mm and smaller, enhancing the overall cohesion and load distribution capabilities of ICEB's wall. Additionally, RC band beam positioned at 1458 mm from the footing, with a depth of 152.4 mm and two Grade-60 #3 rebars were provided having steel ratio of 0.36%.

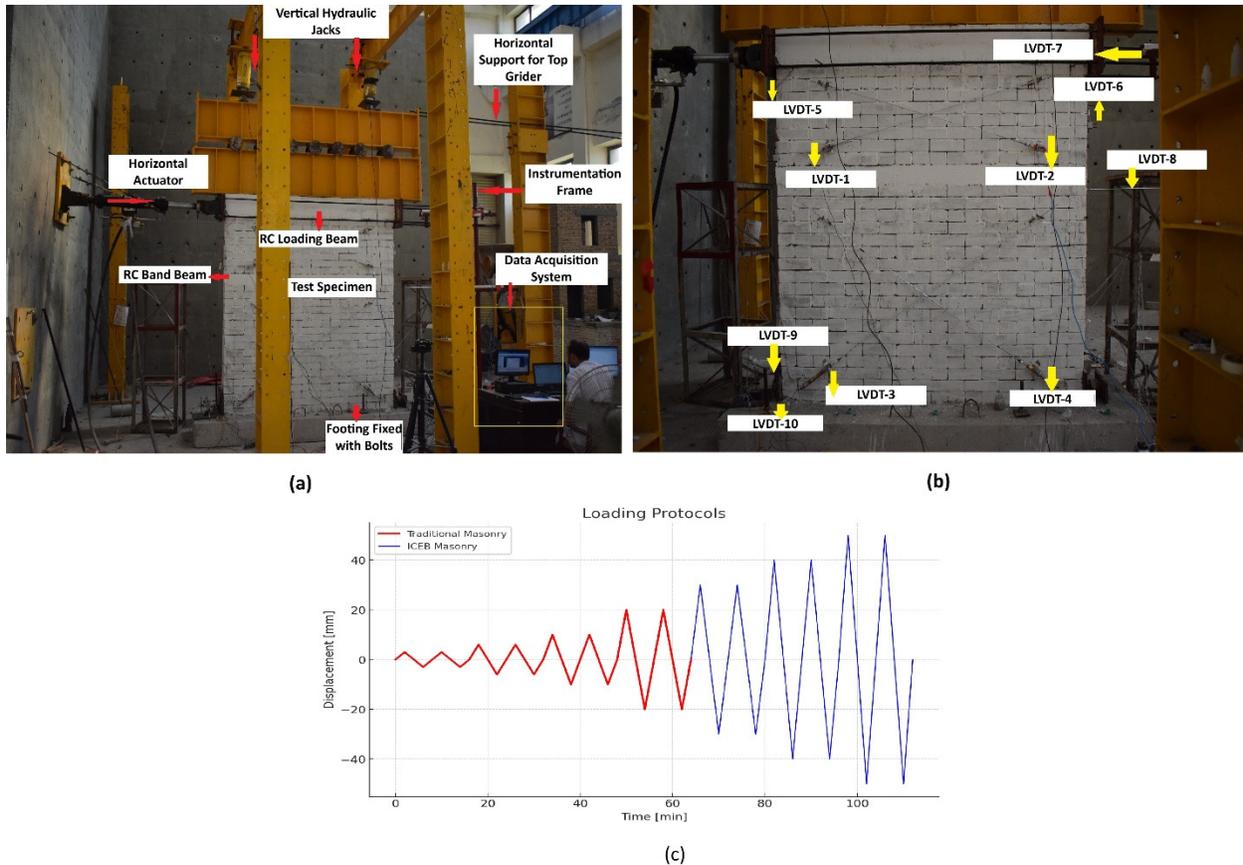
**Fig. 2. (a) Detailed setup and (b) Instrumentation layout and (c) Loading protocols**

The in-plane lateral cyclic loading tests of traditional mortar-bonded and interlocking masonry walls were set up and carried out at the Structural Dynamics Laboratory, National University of Sciences and Technology, Islamabad. The specimens were constructed on 3048 mm × 915 mm × 254 mm footing which was connected to the strong floor using six bars of 25 mm diameter, which were post-tensioned to the maximum extent possible by hand tools, using additional levering for tightness, to ensure a secure attachment. The axial load of approximately 0.18 MPa was applied through two vertical hydraulic jacks equivalent to the dead load on the first story of two-to-three-story masonry buildings. To provide uniform distribution of axial load and avoid eccentric loading across the width of the walls, seven lubricated steel rollers were placed at equal distance and another steel girder was placed above through which the axial load was generated on the wall. The lateral load on the wall was applied at the top concrete beam using a servo-controlled hydraulic actuator. The actuator is capable of ±250 mm stroke range and 250kN loading capacity. The test setup and instrumentation are shown in Fig. 2 (a) and (b).

The servo-controlled hydraulic actuator is equipped with itself as a load-monitoring device. For axial load, two load cells were positioned at the location of the two vertical hydraulic jacks. A total of ten Linear Variable Differential Transformers (LVDTs) were placed on the samples. Four of them were placed diagonally to measure the combined effects of shear and axial force. Two LVDTs above and two below the band beam. Two LVDTs were placed on the sides to capture the vertical deformation along the wall.

To measure the in-plane lateral displacement at the top, LVDT was placed at the top beam level. Additionally, one LVDT was installed at mid-height. The data was logged using the HBM data logger system. High-definition cameras were used to document the progressive damage to walls during tests.

The test procedure comprised two steps, axial pre-compression and lateral cyclic loading. The axial load was gradually applied equally through two vertical jacks placed above the wall. Displacement-controlled cyclic loading was applied, starting with 3 mm up to a maximum of 20 mm for traditional mortar-bonded masonry and 50 mm for interlocking mortarless and grouted masonry as shown in Fig. 2 (c). The loading speed was adjusted to maintain a constant cycle duration and each displacement cycle was repeated twice. The tests were terminated once the lateral load resistance dropped by more than 20% from its peak strength, in accordance with the acceptance criteria outlined in FEMA 356 and ASCE 41.

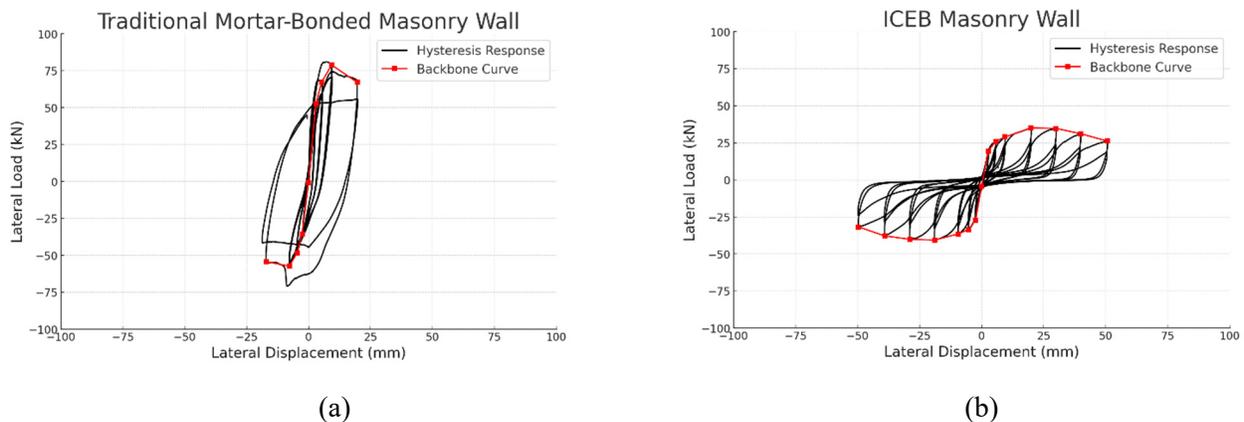
**Fig.3. Hysteresis loops of (a) traditional and (b) ICEB masonry walls**

The global hysteresis response in terms of lateral force and lateral displacement at top beam level of both the traditional mortar-bonded and ICEB's masonry walls are presented in Fig. 3. Initially at the 3 mm cycle, due to the elastic behaviour of both traditional and ICEB masonry walls demonstrated narrow hysteresis loops. The initial stiffness of traditional mortar-bonded masonry shows higher stiffness, measured at 16.2 kN/mm (push-direction) and 15.1 kN/mm (pull-direction), compared to ICEB masonry wall 7.1 kN/mm (push-direction) and 7.3 kN/mm (pull-direction). The high initial stiffness of mortar-bonded is primarily due to the cohesive bonding of bricks with mortar. In contrast, the lateral resistance in ICEB masonry is facilitated by the combination of bonding grout, mechanical shear keys and friction along bed and head joints. The presence of multiple friction contacts within the ICEB wall contributes to a more flexible and ductile system.

At 6 mm cycles, both walls began to show wide loops indicating structural damage in the walls. The traditional wall showed horizontal cracks at the bottom rows of the brick-mortar interface, typical of stress concentration and material failure under cyclic loading. Conversely, the ICEB masonry wall displayed vertical hairline cracks within the interlocking bricks at the location of interlocking key and grout lines below the band beam level laid in a stretcher pattern, indicating stress concentration due to material discontinuities. The cracks didn't follow a clear diagonal path as typically occurs in conventional mortar-bonded masonry. At 10 mm cycles, the traditional wall reached its peak 81 kN (push-direction), hysteresis loop became considerably wider, a clear indicator of structural damage. Diagonal cracks are initiated at the brick-mortar interface starting from the band beam corners to the base. However, the ICEB wall shows further crack initiation only in the stretcher-laid bricks and cracks growth in those from the previous cycle.

As the cycle amplitude increased to 20 mm, the lateral resistance in pull-direction reached to its peak 70.6 kN and hysteresis loop broadened significantly, diagonal cracks from the previous cycles turned into complete separation of wall and significant corner crushing. No cracks were observed in the wall above band beam due to restricted movement in the stiffer section of masonry above. The test was stopped for traditional mortar-bonded masonry at this stage. Notably, the ICEB wall at 20 mm cycles shows pinching within the loops with additional cracks in interlocking bricks at the location of interlocking keys, few headers laid interlocking bricks crack at this stage. The test was continued with an increase in displacement for the ICEB masonry wall, at 30 mm the ICEB showed the maximum lateral resistance of 35.1 kN (push-direction) and 40.6 kN (pull-direction), followed by an increase in crack severity and complexity, yet prominently diagonal with base corners crushing of the band beam. By 40mm and 50mm cycles, the lateral resistance dropped with a wider loop area indicating extensive damage, by experiencing more shear force complete separation of bricks and crushing at lower corners of the wall was observed. Test ended at 50 mm cycles; the lateral resistance eventually dropped more than 20% of peak lateral resistance. No visible damage was observed in the masonry above the band beam. The total energy dissipated by the traditional mortar-bonded masonry wall was computed as 7760 kN-mm over 8 loading cycles, compared to ICEB masonry wall which exhibited greater post-peak stability and residual strength, dissipated a total of 6290 kN-mm over 14 loading cycles, equivalent to approximately 81% of the energy dissipated by the traditional wall.

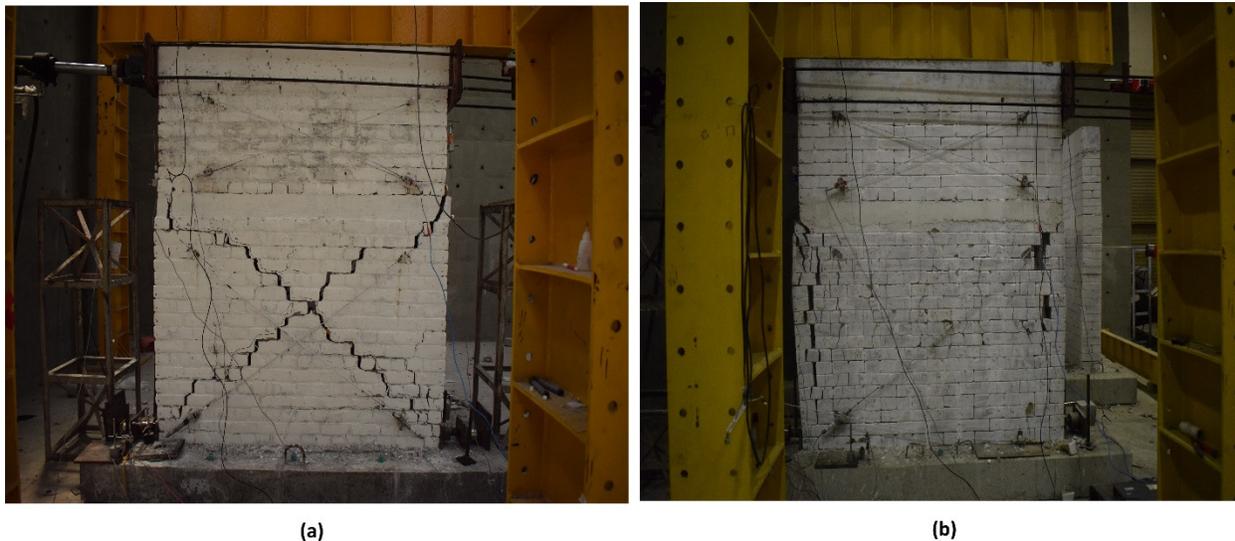
**Fig. 4. Damage pattern after test (a) traditional masonry and (b) ICEB masonry**

- Due to limited drift capacity, traditional wall was more prone to brittle failure under higher displacement demand while ICEB demonstrated greater ductility, it can sustain larger displacement without catastrophic failure.
- Damage in traditional masonry is characterized by diagonal cracks that rapidly led to significant degradation in structural integrity. However, damage in ICEB is more distributed across the wall leading to not compromise the overall stability.
- Although the ICEB masonry wall exhibited 81% of the total energy dissipation of the traditional mortar-bonded masonry wall, its enhanced post-peak stability and residual strength underline its outstanding seismic performance in terms of structural integrity.
