## Much Ado about Sandstone: Technical Guidelines for Selecting New Sandstone for Localized Use in Preservation Projects to Balance Long-Term Durability and Compatibility with the Existing Stone

Matthew Bronski<sup>i</sup> and Jordan Dick<sup>ii</sup>

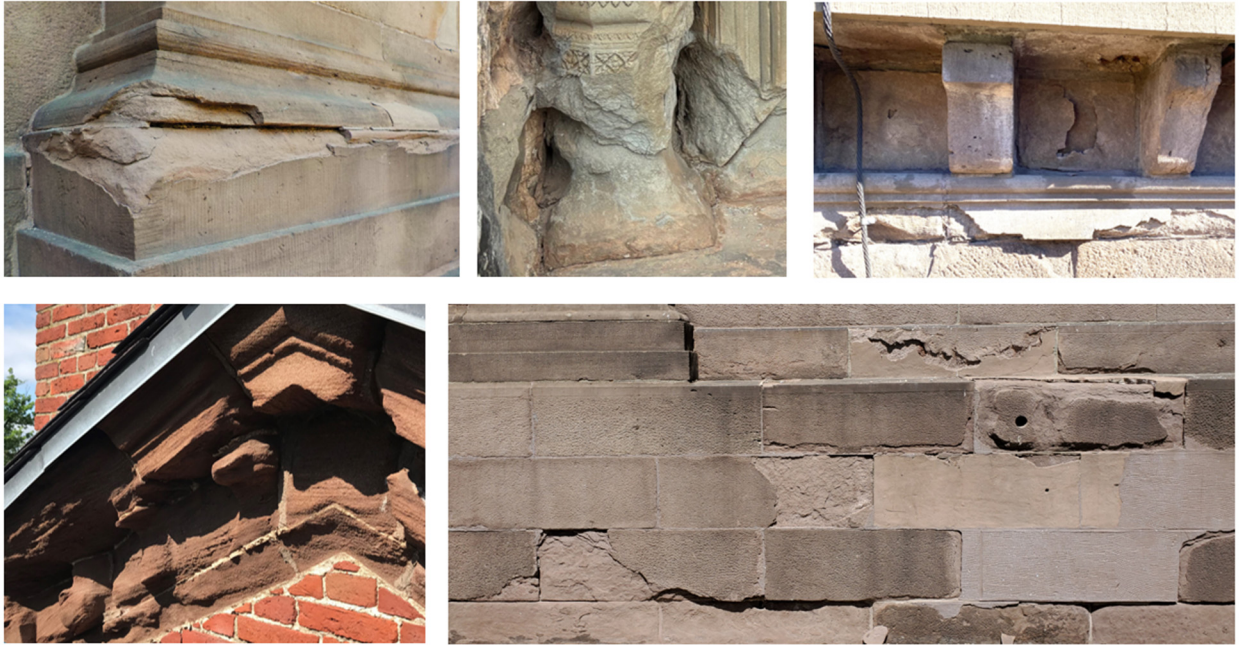
**Figure 3: Examples of Sandstone in Poor Condition**

Poor Condition: Overall the area of stone has widespread and more severe deterioration that may include severe loss of surface depth, stone cross section, strength and hardness, and may include stones with severe cracks and stones that have become friable.

\*\* Examples of Poor, Fair, and Good condition of existing stone on building are shown below.

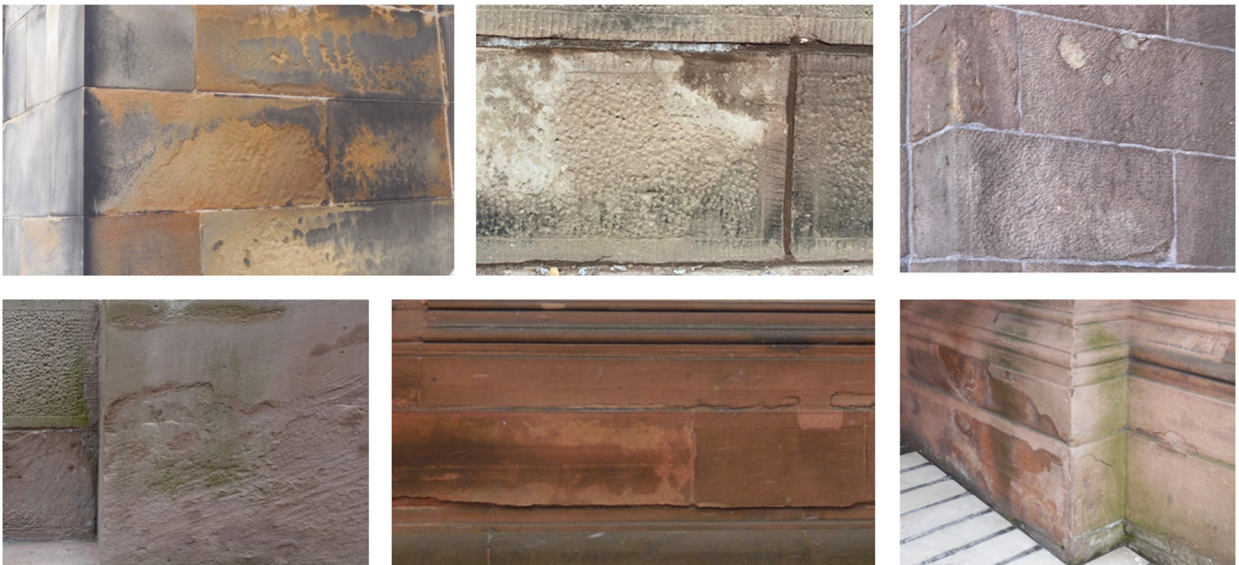
**Figure 4: Examples of Sandstone in Fair Condition**

Fair Condition: Overall the area of stone has a fair amount of noticeable deterioration, which may include deeper loss of surface from erosion or scaling, and wider cracks, but does not compromise the overall strength or integrity of the stone element.

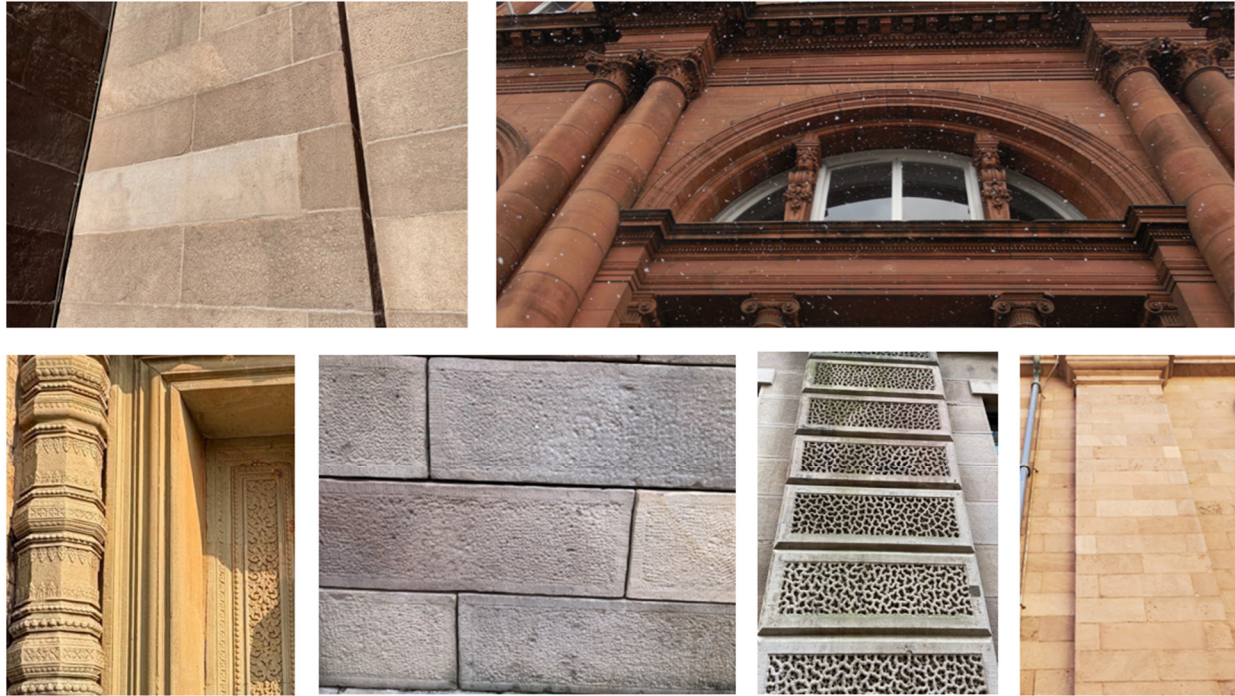
**Figure 5: Examples of Sandstone in Good Condition**

Good Condition: Overall the area of stone has little noticeable deterioration, and any deterioration is very limited, localized, and minor, and does not compromise the overall strength or integrity of the stone, such as surficial surface erosion, shallow scaling, or hairline cracks.

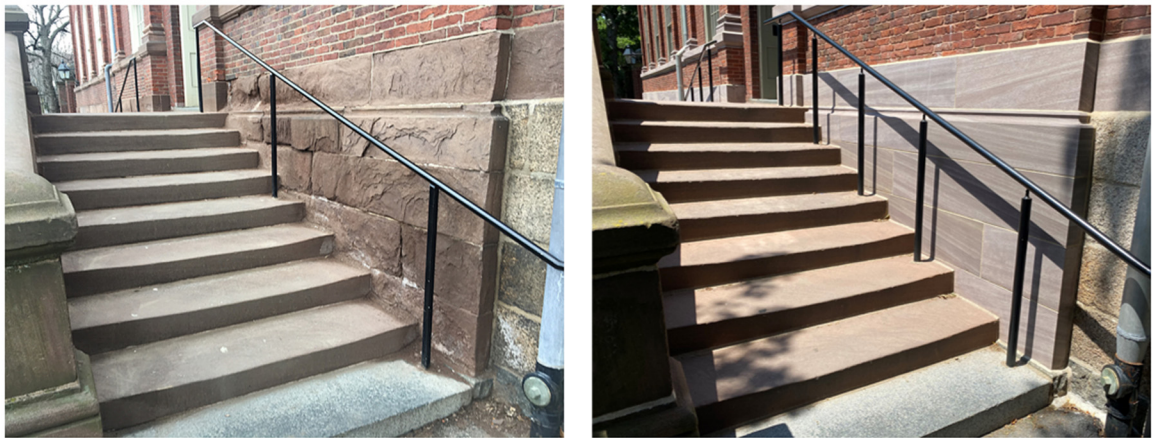
**Figure 7: Replacing and Harvesting Stone at an Entire Architectural Element**

- Entire architectural elements: As indicated in Table 2, in some cases an entire architectural element with a severe exposure (e.g., a water table at grade, a projecting ledge, an unused chimney) is in poor condition with widespread deterioration, whereas in other areas of the facade the stone is in relatively good condition, and requires only localized repairs. In these situations, time and exposure to the elements have demonstrated that the original stone was adequately durable for the majority of the facade, but not for the severe exposure area and element. In this situation, ALL stones at the deteriorated severe exposure area (e.g., the water table at grade in Figure 6) can be removed and replaced with new (significantly more durable) stones that are suitable for the severe exposure, where the original stones were not. Then, the deteriorated and unsound portions of the removed original stones can be cut off and discarded, and the remaining sound portions of the original stone can be cut and used for multiple partial stone replacements elsewhere on the facade, where time and the elements have shown the original stone to be suitably durable. In terms of preservation/conservation philosophy, some arguments against this approach are that it is not taking a minimalist, “less is more” approach to conservation and is removing and relocating some portions of intact sound stone. One preservation philosophy counterpoint against this argument is that time and the elements have clearly demonstrated that the original stone cannot last in this severe exposure, and if left in place it is just a matter of time before the remaining original stone is lost to deterioration. Thus, by removing it now, and using it for localized repairs in areas of the facade with gentler exposures, one can save original historic fabric that would otherwise be lost, and thereby preserve more original historic fabric over the long term.
