**15<sup>th</sup> Canadian Masonry Symposium**  
**Ottawa, Canada**  
**June 2-5, 2025**

## **Designing Stone Dutchman Repairs in Slender Stones**

**Ellen M. Laase<sup>i</sup>**

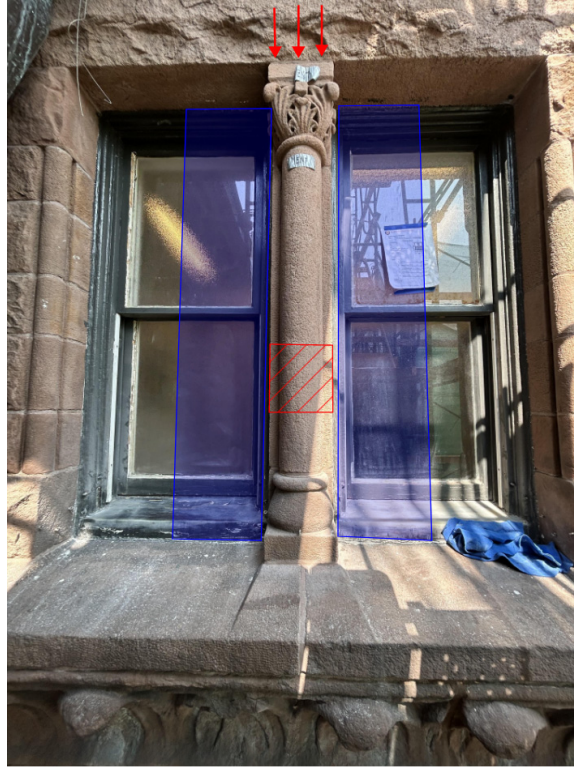
**Figure 2: Dutchman repair in slender vertical stone. Red arrows represent gravity loading; blue hatch represents tributary area of wind loading imparted from adjacent windows.**

Often, dutchman repairs are located within a large, parent stone in the field of the wall. With these dutchman repairs, the gravity loads within the load-bearing walls have alternative load paths both around the repair and behind the partial depth of the repair (Fig. 1). However, in some cases, the stone spalls are located within tall, slender stones, such as vertical mullion stones between windows and must support both the gravity loading from the lintel above the window and the lateral loading from wind on the adjacent windows (Fig. 2).

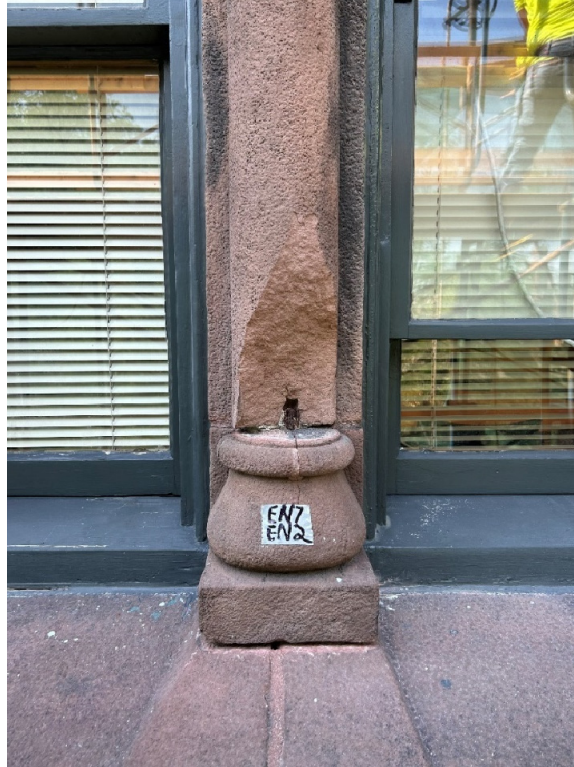
**Figure 3: Stone spall in tall, slender stone.**

The construction of these tall, slender stones typically includes ferrous dowels, which, when continually exposed to moisture, can corrode, expand, and spall the surrounding stone (Fig. 3). When designing dutchman repairs in these tall, slender stones, the anchorage methods must be selected to resist the lateral loading imparted from the adjacent windows tributary area, support the full-depth of the repairs, and allow for concealed installation above and below the stone.

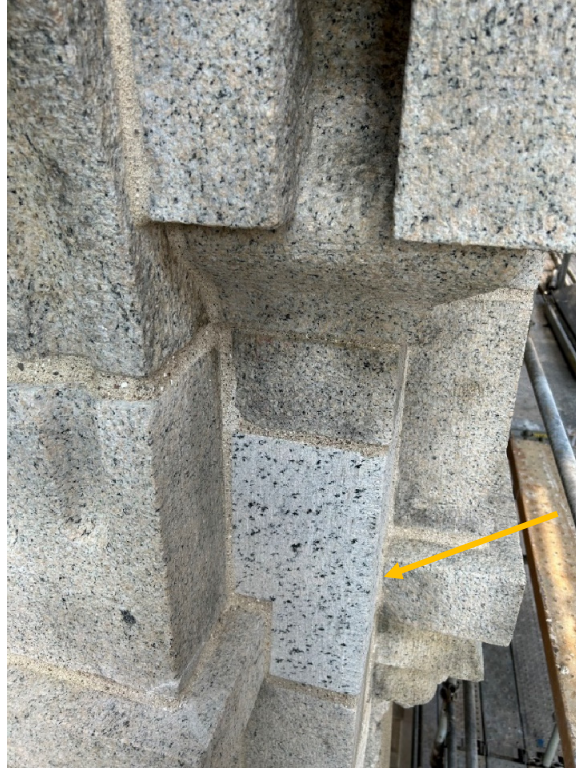
**Figure 4: Milford Pink granite quarried in the early 1900s vs. 2000s (arrow).**

To provide a dutchman repair that is compatible and blends in with the existing stone, the color, texture, and profile of the existing stone must be considered. Stones like limestone or sandstone generally have a uniform color, but for granite, which consists of many different colors within one stone, the distribution of the color within the stone (i.e. the amount of black, pink, and green on a gray base color in Milford Pink granite) must also be assessed. Note that even stone sourced from the same quarry can have a different appearance if quarried at different times (Fig. 4).

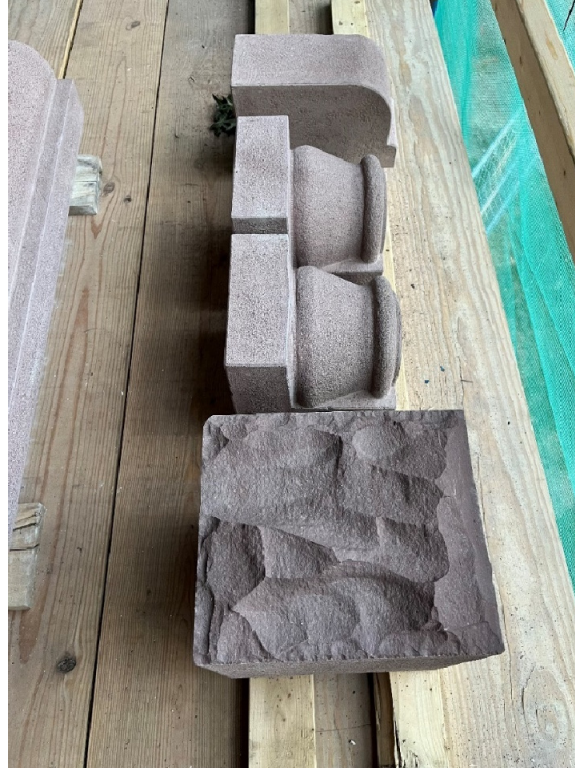
**Figure 5: Bush-hammered (top) and quarry-faced (bottom) profile showing color changes from tooling.**

The finished texture and tooling of the stone can also greatly impact the appearance of the stone. The finish tooling of the dutchman repair should match the finish tooling of the existing stone (i.e. quarry-faced, bush-hammered, honed, etc.). For example, in stones like sandstone or quartzite, the color of the stone will often appear significantly lighter in a bush-hammered finish than in a quarry-faced finish, so when assessing stone for dutchman repairs, samples with the same finish tooling as the existing stone should be reviewed to ensure an appropriate match (Fig. 5).

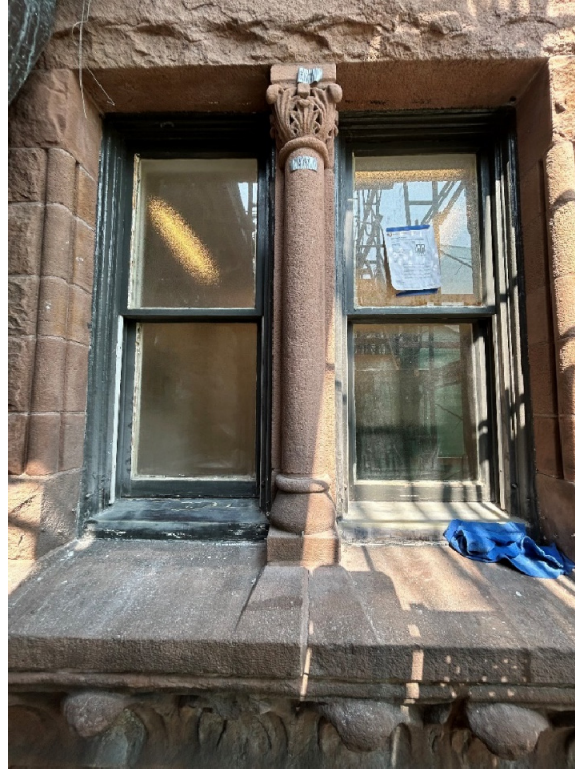
**Figure 8: Vertical mullion between windows.**

When working with a tall, slender stone, such as a vertical column between windows, the same considerations for stone selection apply to both the aesthetic and technical properties. However, unlike a dutchman repair in the field of the wall, a dutchman repair in a tall and slender stone between windows must support both the gravity loading from the lintel above the window and the lateral loading from wind on the adjacent windows imparted through the connections of the windows into the slender stone column or mullion (Fig. 8).

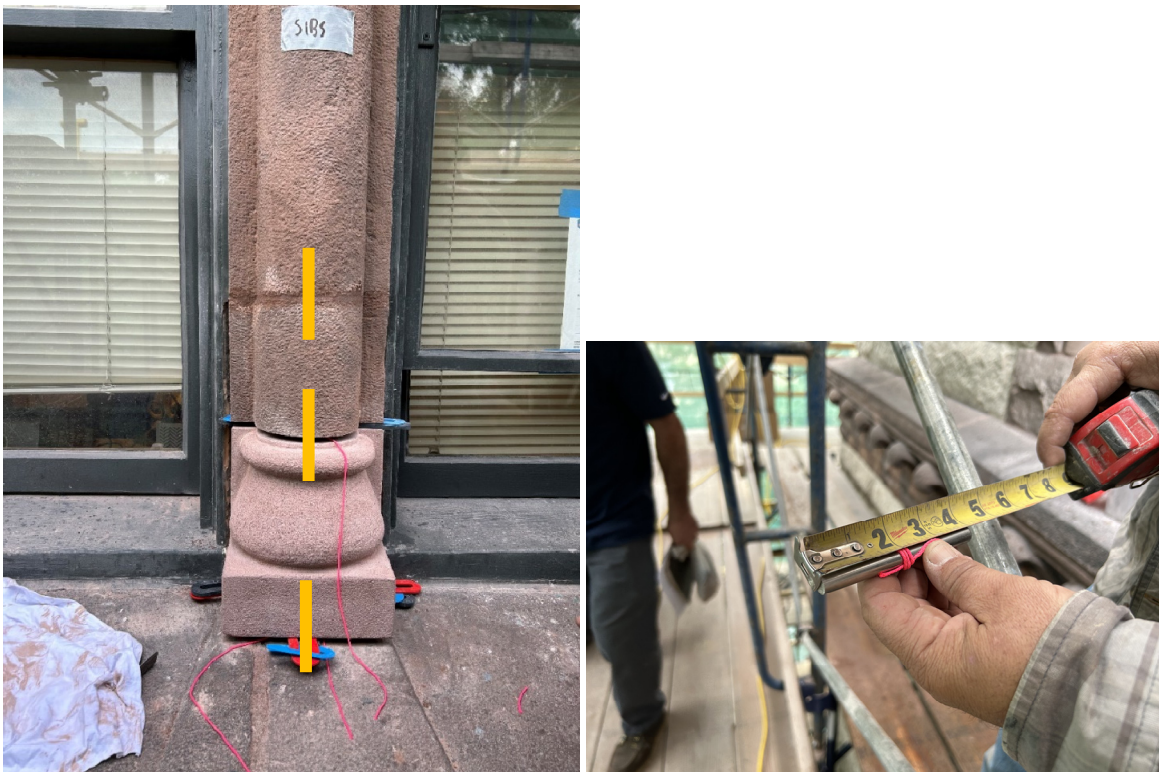
**Figure 11: Completed dutchman repair using drop pins. Yellow lines indicate the location of concealed drop pins within the completed repair.**

Drop pins are smooth, concealed dowels designed to “drop” into the lower stone to engage both the dutchman and parent stones. For installation, an elongated hole must be drilled in the upper stone so the drop pin can be pushed up to allow the lower stone to slide into place (Fig. 10). As the dutchman is installed, the drop pins at the top and bottom can be held in place using putty knives, or strings threaded around the drop pin within the hole. Once the dutchman is in place, the putty knives are removed or the strings pulled, to allow the pin to drop into the holes in the lower stone (Fig. 11).
