Early Veneer Walls: A Learning Step in the Evolution from Mass Masonry to Cavity Walls

ABSTRACT

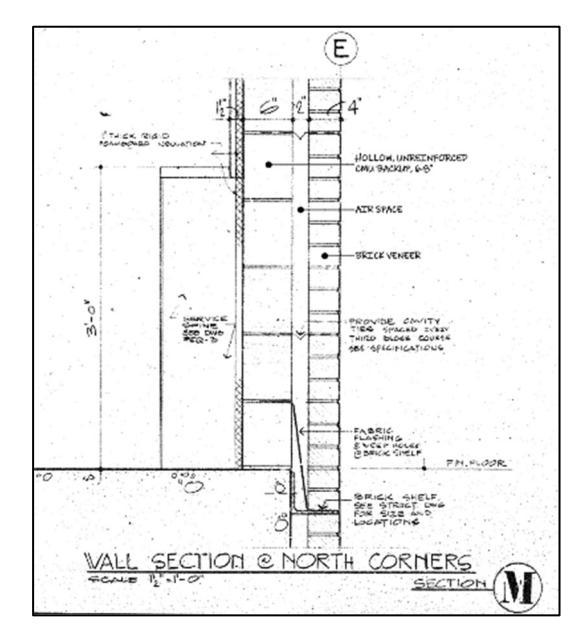
Examining the different components of an early veneer wall system provides an understanding of how the issues associated with those systems inspired updates to the building code and what is known today as the cavity wall. Shortcomings of these veneer wall assemblies are summarized herein, using a generic case study building to illustrate the resulting performance problems and remedial options. The case study building is fourteen stories, constructed in the 1970s, with a reinforced cast-in-place concrete structure, CMU backup walls, and brick veneer. The exterior wall assembly consists of the following components from exterior to interior: standard 92 mm (3.6 in.) brick veneer, 50 mm (2 in.) air space, 152 to 208 mm (6 to 8 in.) CMU, and 25 mm (1 in.)-thick rigid insulation (Fig. 1). Cavity ties include horizontal metal truss reinforcing spaced every third CMU course, and relieving angles are located at each floor with fabric flashing and weep holes above.

Figure 1: Typical early veneer wall section [3]

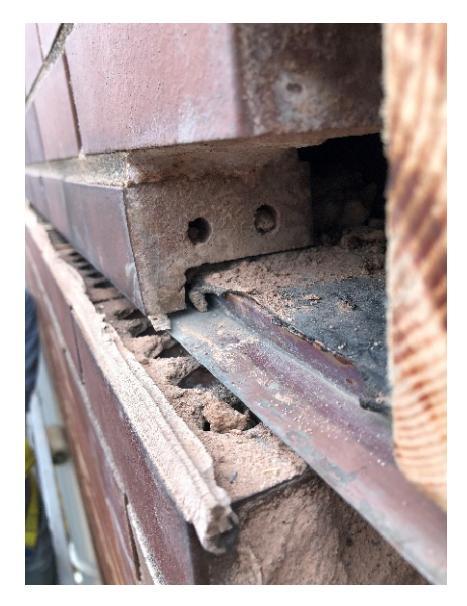
Multiple issues related to the backup wall and ties were observed in the case study building, as they are common in early veneer walls. Using ground-penetrating radar (GPR), the CMU backup walls were confirmed to be ungrouted, unreinforced, and not mechanically connected to the concrete structural frame. In fact, open gaps were documented between the CMU and concrete spandrel beams at several exterior exploratory openings. The net tensile stresses were calculated in full-height walls per the original code during construction and the current code, and then compared to the tensile stresses allowed by each code. The findings showed the demand-to-capacity (DCR) ratio using the current code was more than one, indicating the walls are overstressed when subject to code-prescribed loads. The original code during construction did not include values for allowable tensile stress, which was interpreted to mean that tensile stresses were not permitted in unreinforced masonry.

The analysis indicated the CMU backup walls were not adequate to support the design wind loads prescribed by either the original code of construction or current codes. There was no evidence that the above deficiencies compromised the structural performance of the CMU backup walls, which had been in place for more than forty years. This is likely due to the building not having exposure to a design wind event and some inherent factor of safety. However, through continued work on the building, several locations of horizontal displacement of the brick veneer below relieving angles were observed (Fig. 2a). This displacement, which was up to 38 mm (1.5 in.) at one location, also included the CMU backup (Fig. 2b). The assessment concluded this displacement was caused by lack of grout and reinforcing within the CMU walls, and lack of mechanical attachment of the backup to the structure.

Figure 2a: Displacement of brick veneer below relieving angle

Structural deficiencies such as those found in this case study building complicate the design of repairs to early veneer walls. Even smaller local repairs must consider the potential impact to the structural integrity of the wall when the backup wall cannot be relied upon for attachment of replacement veneer or miscellaneous exterior supports for new signage or similar elements. Further, any long-term repairs for these buildings must address the backup walls' inability to resist design wind loads. Ultimately, this was addressed in this case study project by designing a replacement cladding system that completely bypassed the existing CMU backup walls, significantly reducing the lateral load imposed on the backup walls.

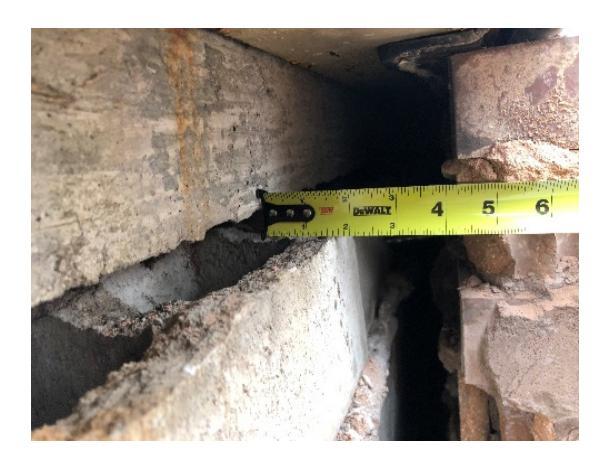
Figure 2b: Displacement of CMU backup wall

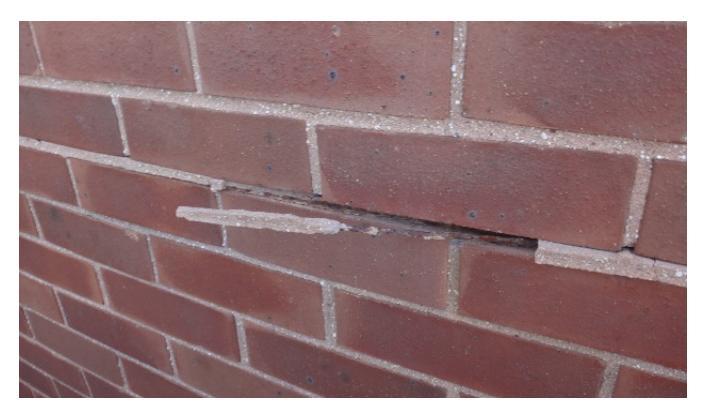
In addition, the horizontal metal truss reinforcing tying the brick veneer to the CMU backup wall at every sixth brick course had significant corrosion, despite the lab-confirmed presence of a corrosion-resistant coating. This corrosion buildup within joints caused large sections of mortar to fall from the building as the corrosion product pushed the mortar out of joints (Fig. 3). Further, the truss reinforcing restricted differential movement. The corrosion product buildup exacerbated the brick veneer horizontal displacement. The client and project team were concerned about the impact of continued corrosion on the veneer's lateral attachment and structural integrity.

Figure 3: Corroded metal truss reinforcing and debonded mortar

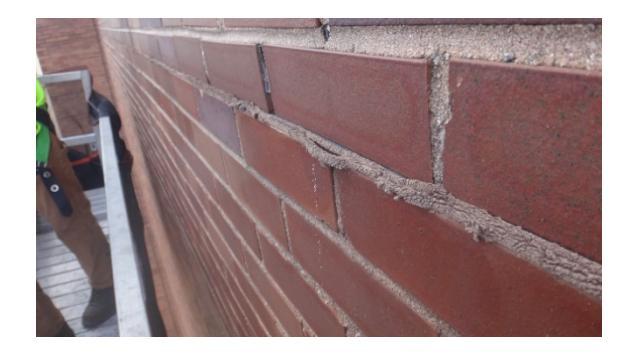
Despite these efforts, in 2017, compressed sealant at horizontal expansion joints below relieving angles (Fig. 4) and horizontal displacement of brick veneer adjacent to window jambs were observed. Exploratory probes further showed compressible filler below the angles had been compacted enough to show the imprint of the cores of brick below (Fig. 5). At window jambs, brick veneer extended to the interior and was installed tight to the underside of the concrete spandrel beam, with no provisions for brick expansion (Fig. 5). In addition, control joints at window jambs, either original to the building or installed during the 1990 renovations, did not extend through the veneer, undermining their intended purpose.

Figure 4: Compressed sealant at horizontal expansion joint below relieving angle

The original construction drawings for the case study building showed vertical control joints at building inside corners and adjacent to some windows. Horizontal expansion joints were not shown below relieving angles. Review of documentation from previous repairs indicates multiple attempts were made to add expansion joints. Drawings and photographs from 1987 show backer rod and sealant were installed below relieving angles at select locations where cracks had developed, primarily at building corners. In 1990, the building underwent widespread exterior renovations, which included restoration of existing control joints, the addition of new control joints, and installation of horizontal expansion joints below all relieving angles.

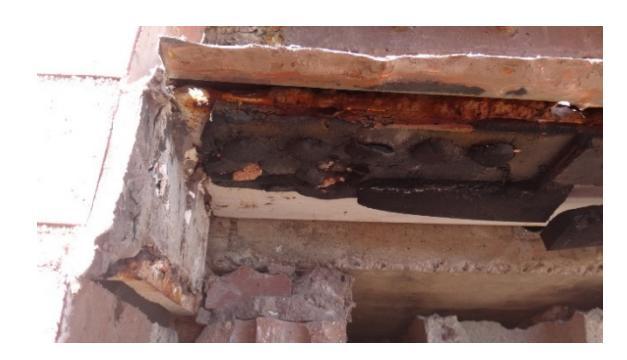
Figure 5: Compressible filler below relieving angle with imprint of brick core holes

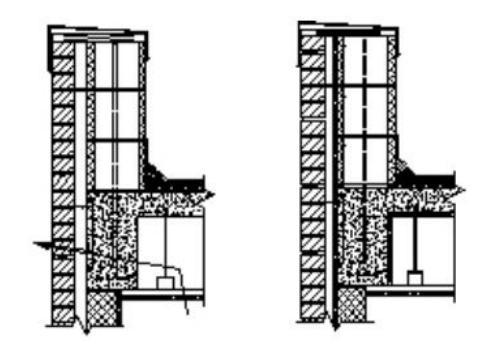
A lack of insulation within the wall cavity causes thermal bridging where interior insulation is interrupted at slab edges, columns, and parapets (Fig. 6) [11]. This thermal bridging can lead to issues at the interior of the building, such as condensation and occupant discomfort. In the winter, humid interior air will condense on cold exterior fenestration, walls, and framing, and can lead to damage to finishes, corrosion of concealed studs/structure, organic growth, and "ghosting" (localized dirt accumulation) at stud locations, among other issues. Occupant discomfort most commonly occurs at floor slabs adjacent to exterior walls. The surface temperature at these areas is often noticeably lower than just a few feet away from the exterior wall due to the interruption of interior insulation at slab edges (Fig. 7) and lack of continuous insulation (c.i.).

Figure 6: Typical thermal bridging where interior insulation is interrupted [12]

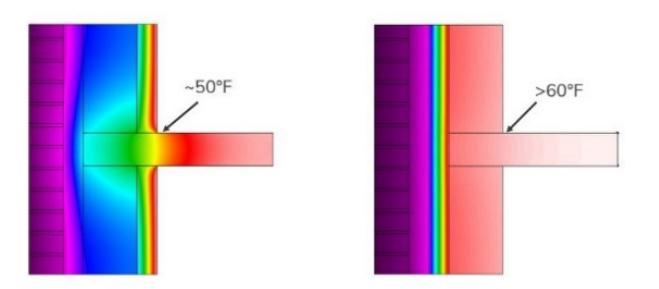
Figure 7: Thermal image comparing floor slab temperature adjacent to wall assemblies with interrupted interior insulation (left) vs. continuous exterior insulation (right)

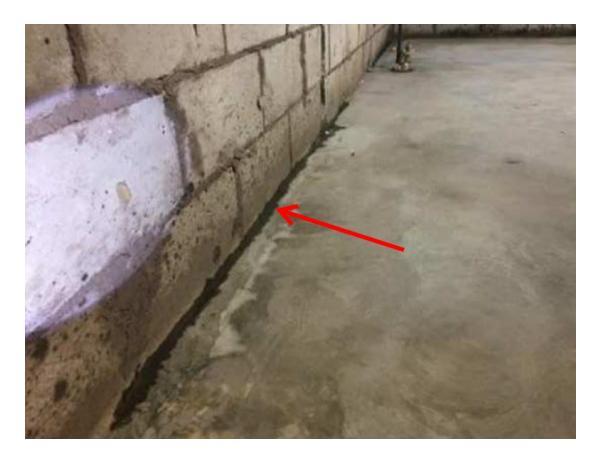
The lack of air and water barriers at field of walls often leads to air and water infiltration. Inconsistencies in masonry infilled backup walls, such as cracks and voids, will allow water that does not effectively drain down through the air gap and out at flashing locations to leak to the interior (Fig. 8). Even though flashings are required at angles, flashings sometimes allowed water to leak behind the flashing onto steel angles and to the interior. Today, such situations are avoided by providing continuous, shingle-lapped waterproofing membranes at walls and transitions, and by sealing terminations to membranes, such as with termination bars and sealant and added end dams.

Figure 8: Water penetration at interior wall-to-slab joint

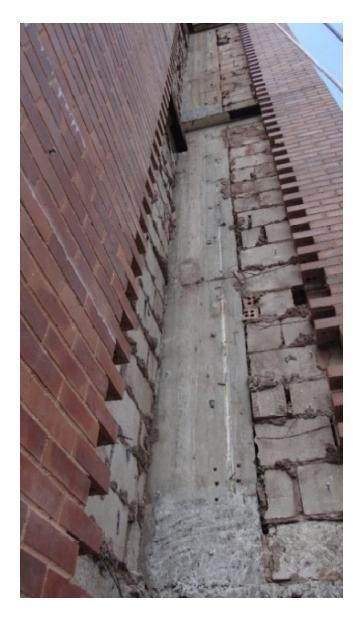
The case study building experienced water leaks due to lack of waterproofing at field of wall locations and discontinuities in the backup wall construction (Fig. 9). These water leaks damaged interior finishes at multiple locations. To address these leaks, localized repairs were designed. At leak locations, the scope included cladding removal, repairing the backup wall to fix discontinuities, and providing a continuous waterproofing membrane, metal flashings at relieving angles, and replacement veneer (Fig. 10). If leaks are more widespread throughout the building, localized repairs are unlikely to be a practical solution, and a full recladding may need to be performed, including waterproofing the face of the backup wall.

Figure 9: Wall assembly lacking air and water barrier, and with discontinuities in the backup wall
